Ballymurrin Stories -Restoring the Quaker Farmstead  
2 The Old Stables

Ballymurrin  
Quaker  
Farmstead

## The Old Stables with Tack Room and Loft

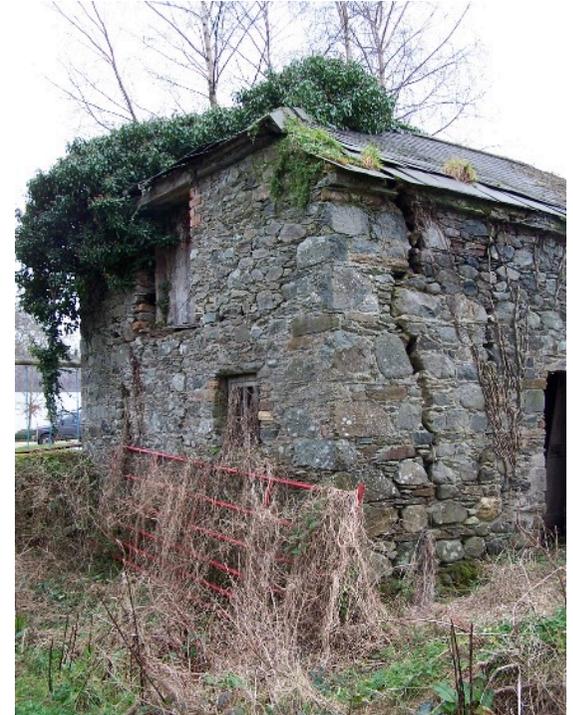
**Above:** Gable with loft opening above. The major structural crack and the unstable wall beside the loft opening meant that replacement of the roof could be achieved only after the stonework was stabilised.

The first step was to create a stable structure to allow the roof to be replaced. There were serious cracks in the lower end of the building, where the tack room and loft are situated. The engineer advised that a rigid steel base should be anchored along the top of outside wall, and attached with long steel pins to it. However until that could be done, it was necessary to decide on appropriate action to deal with unstable stonework on the lower gable wall, the corner which was threatened by two large subsidence cracks making the corner unstable and other patches of stonework on the long wall facing into the paddock. It was agreed that only the stonework affected by instability would be replaced.

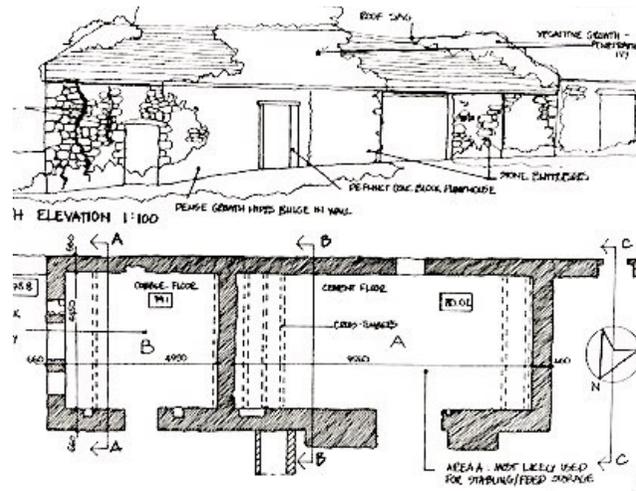
**Above:** Stables building: this is the elevation with a single window, facing the courtyard. The collapse of the roof occurred at around the centre of the stables area, deforming much of the roof.

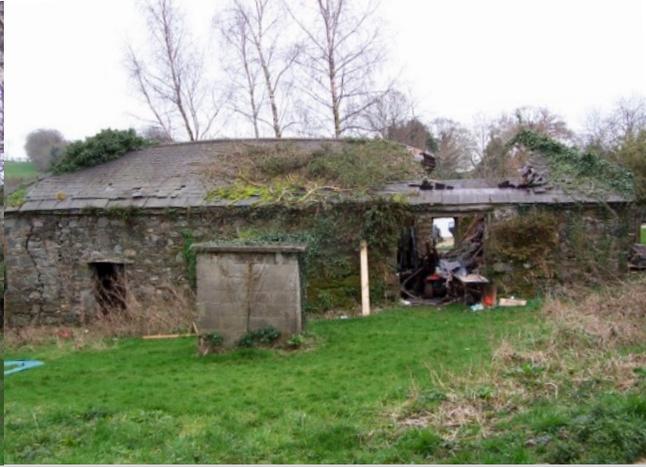
**Above:** The rear of the building after the collapse. The concrete hut, in front of the building, houses the drilled well water pump.

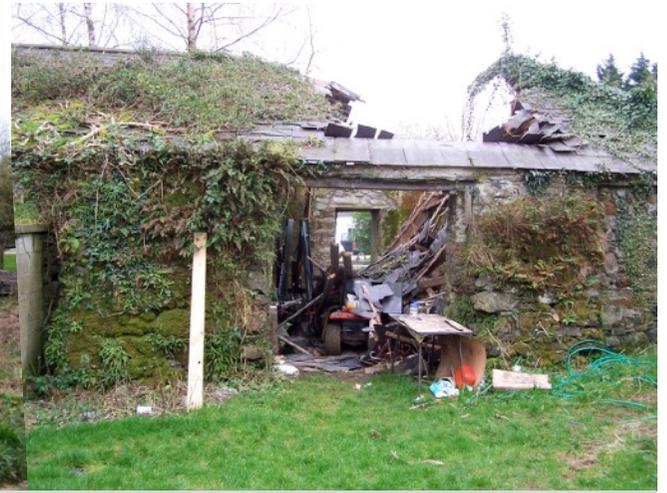
**Above:** The collapse and debris was inside the entrance for the horses. There are two substantial buttresses on either side of the opening, sloping outwards to hold the wall in place. Not the first event to befall this building!

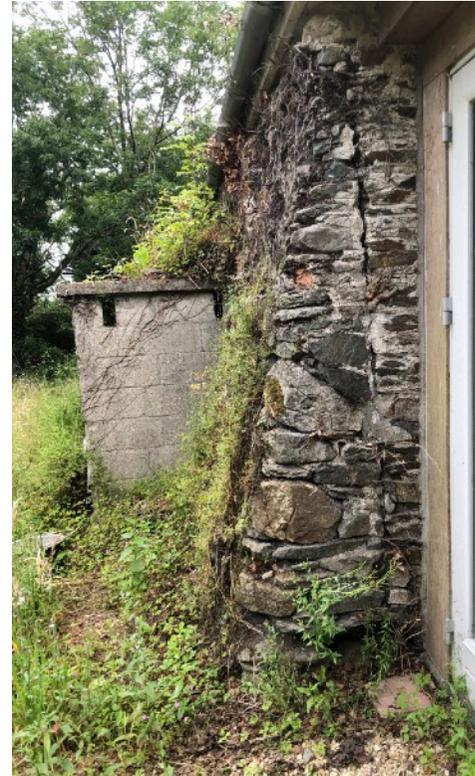
Buttressed walls at the entrance to the stables were originally placed to resist the stresses from walls being pushed out by the weight of the roof. Their additional width is clearly shown at both sides of the opening. Whilst they are not in a good state, they have been held together by plants embedded in their joints. Inside the building large beams span across to stabilise the walls

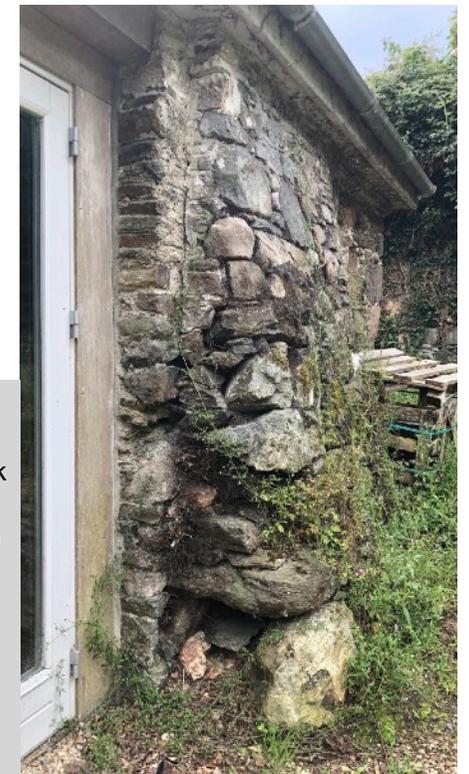
**Left:** a detailed view of the gable, with loft above and the Tack Room below. Careful examination shows how poor the stonework at upper level was. Our stonemason for the job explained how the above area had been repaired with small stones and was not stable. Additionally the stress cracks on the gable and on the long side of the buildings gave notice that further collapse was to be expected. Thus, it was essential to rectify the stonework prior to replacing the roof.

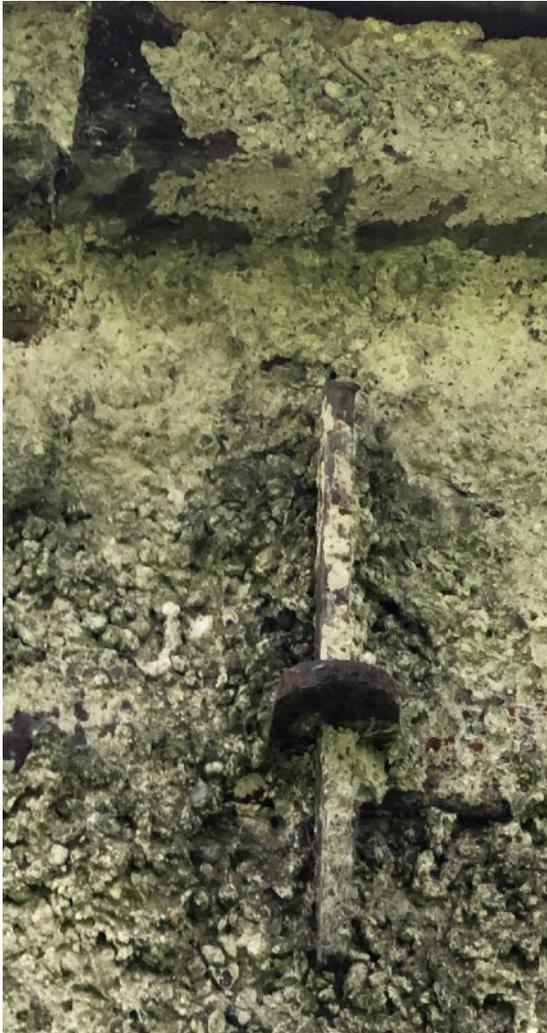
**Above, left** is on the South facade about half way along. It penetrates through the lime and cement finish, just below the eaves and secures the beam inside.

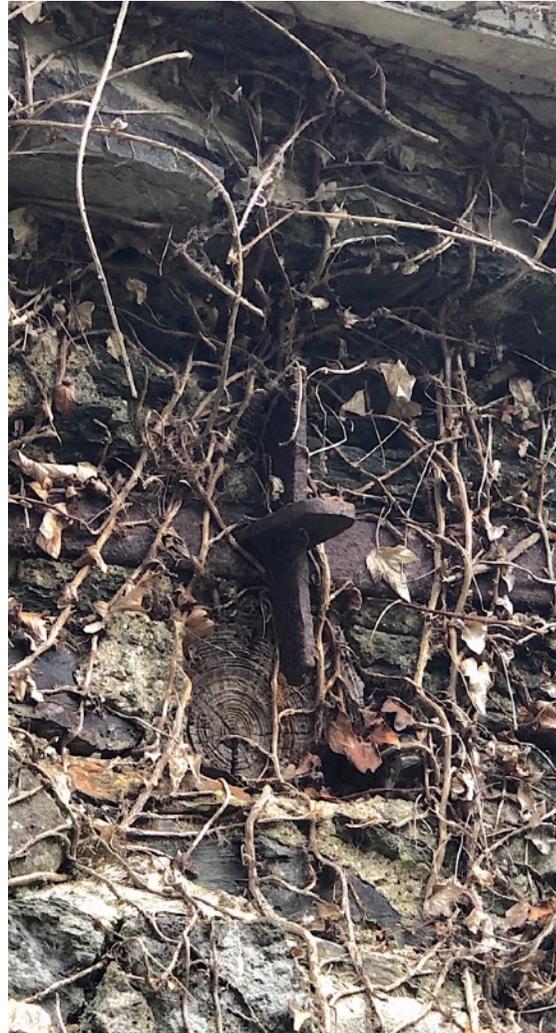
**Above, centre** is on the North facade, similarly half way along and possibly the other end of the same beam. The beam end is visible behind the tie.

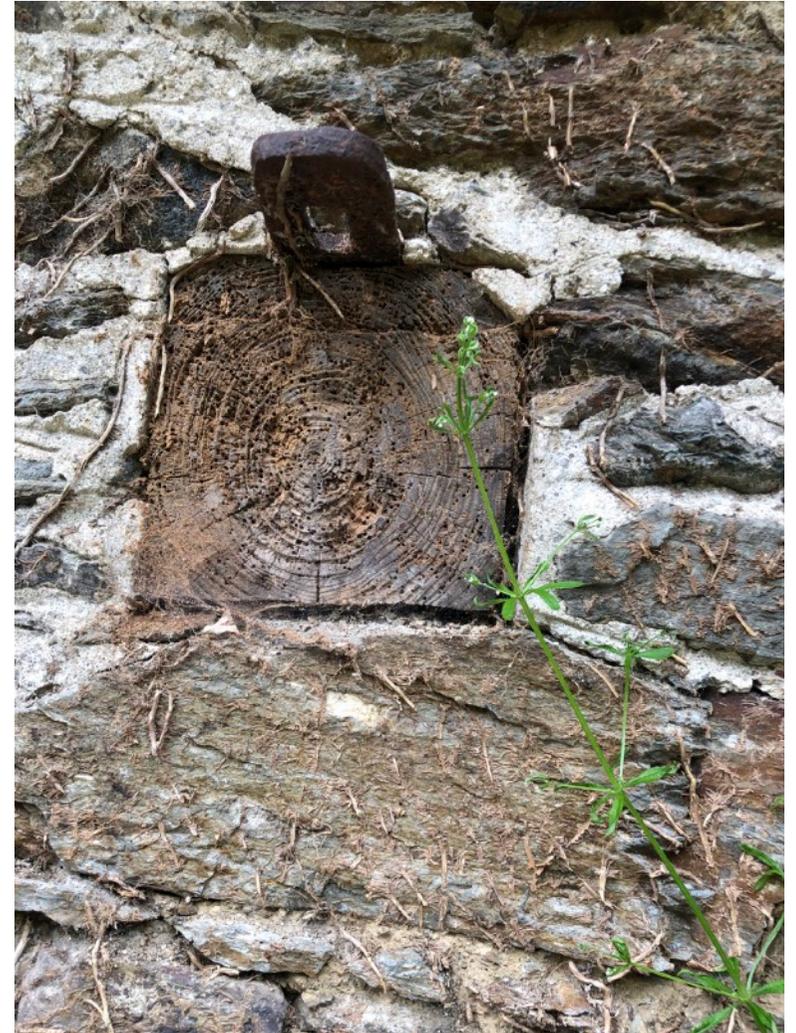
**Above 3** is on the on the South facade close to the entrance to the stables. The timber beam is brought through to the face of the stone wall with a similar iron piece which is attached to the timber. The peg is missing, but was presumably similar to the other two shown.

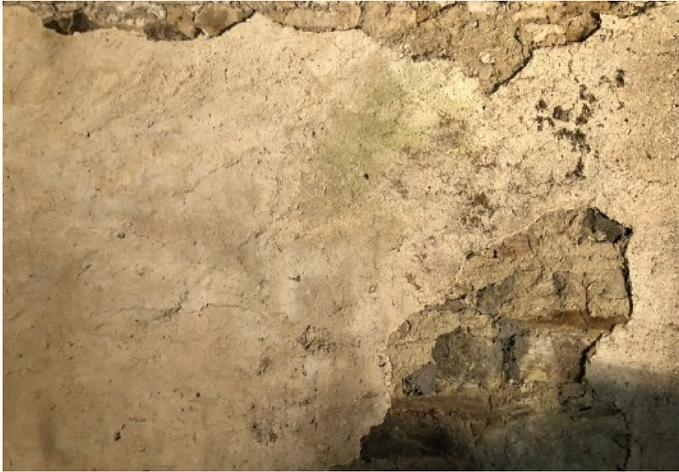
**Above:** although the lime plaster in the stables has sizeable areas of fragmentation, it will be possible to patch those areas with the skills of an experienced plasterer. Note also the extensive plastered areas in the image, **below right**, after the roof had been replaced.

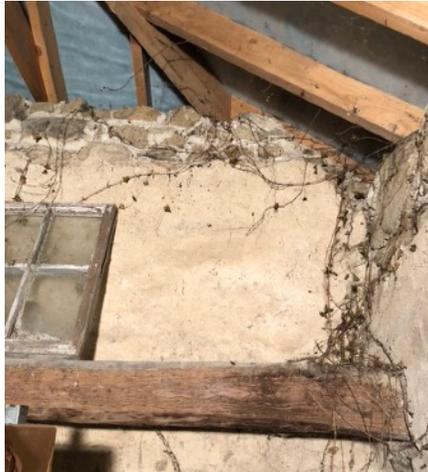
**Above:** This image shows the end of one of the two surviving beams in-situ. A third beam was unstable and was taken down. It has been retained in the building. It is close to the gable on the South side. Its purpose was to act as a tie to stabilise and hold the walls from outward pressure of the collar trusses. The beam went through the wall and was tied with an iron anchor fitting. Those fittings, remaining on the building, are shown on the previous page.
