Ballymurrin Stories -Restoring the Quaker Farmstead

3: The Farmhouse

Ballymurrin
Quaker
Farmstead

3 General Introduction to the Farmhouse

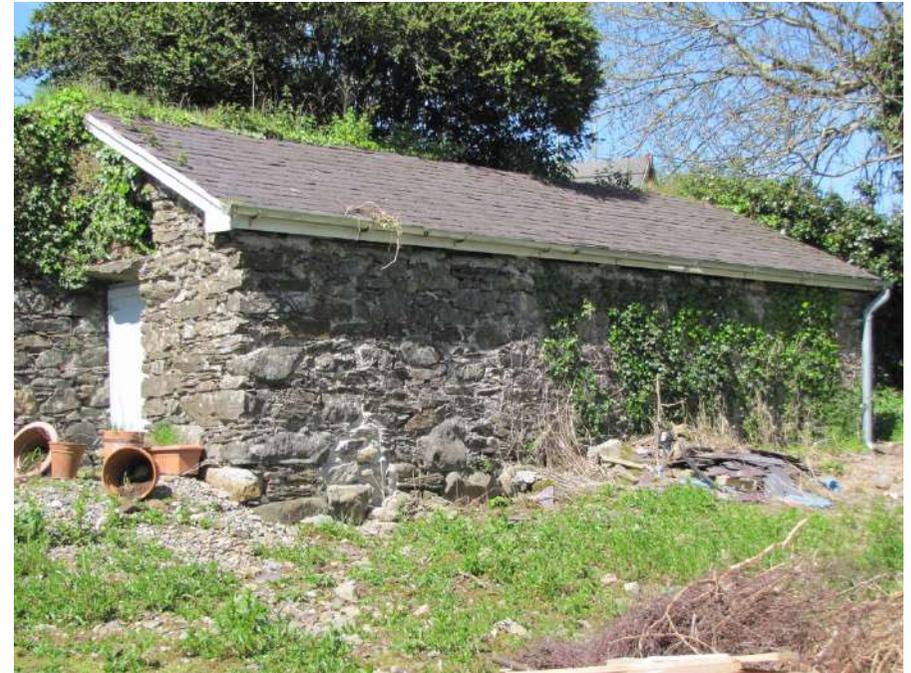
Above: This is not the farmhouse... However it is a vital component in the construction of the farmhouse, as these facilities were built as privies: toilets, or earth closets, alongside the paddock for the stables. This building remains in good condition with a new slated roof recently completed. It has three 'rooms' one at each end, with door and ventilation opening above. The middle space is accessed from the other side, on the edge of the garden attached to the 'dower' house.

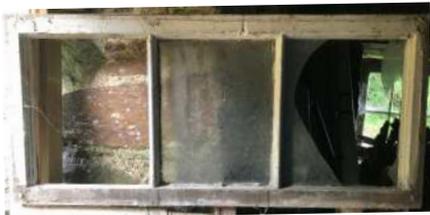
The windows shown, **above right** are the original sliding sash windows, shown here when the house was being upgraded in 1990, just prior to their replacement. Upper windows are the same size as the lower ones. The front door, as seen in the image is a double glazed door replacing a a solid door below a three pane fanlight. The fanlight, app. 40 inches wide, (1m15cm) is still stored in the stables, **below**.

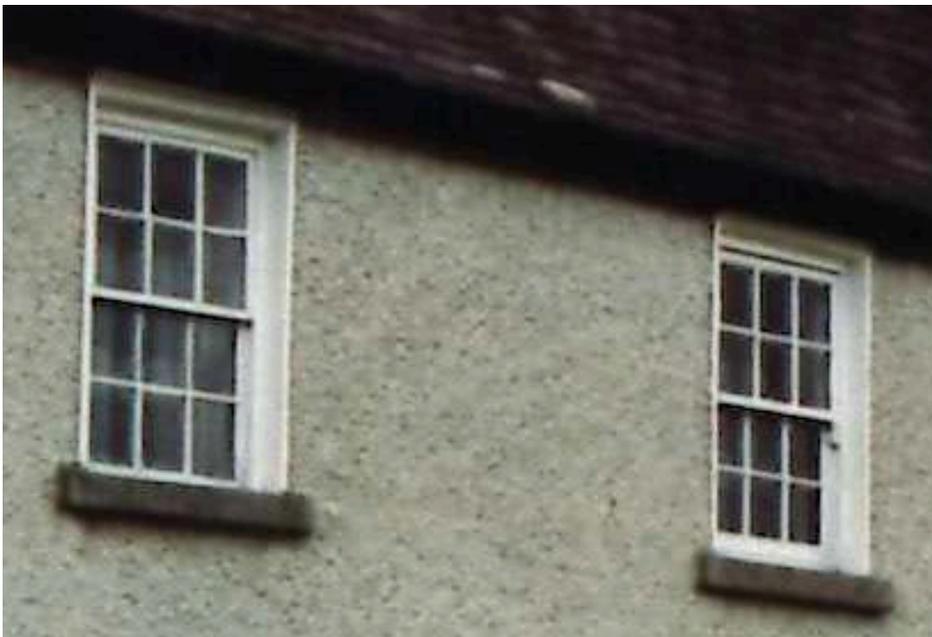
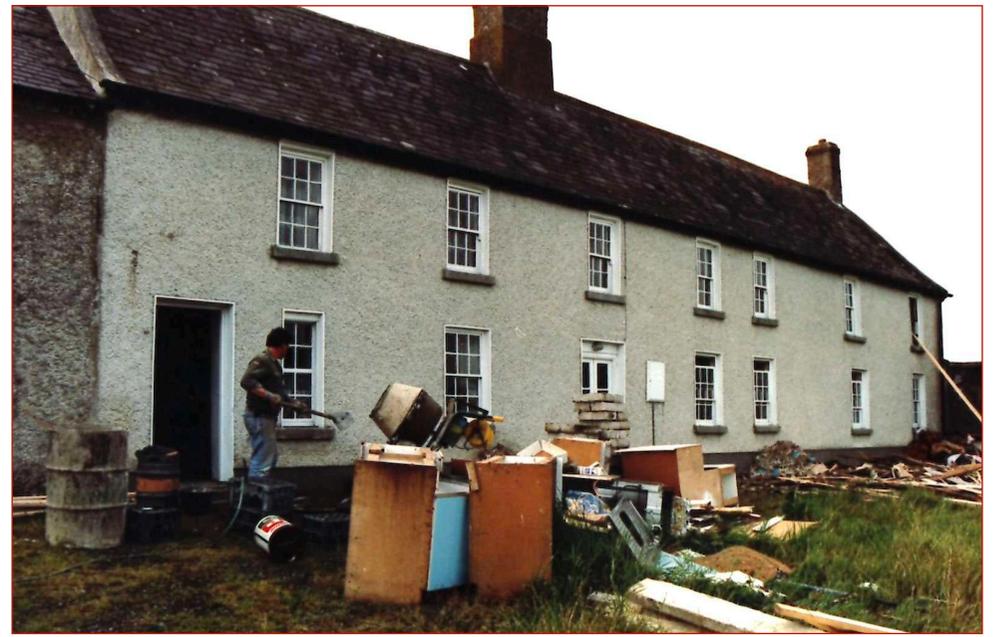
Windows, **Below:** This is a relatively close-up view from pictures taken in 1990, showing the original windows at a larger scale, producing some sense of the original appearance of the frontage. Pictures by David Strawbridge.

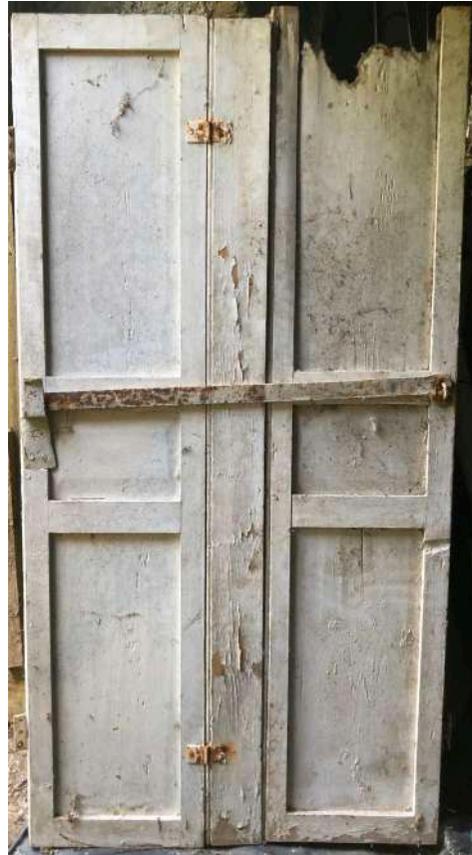
On the right: one of the shutters in the parlour; our living room. The motif on these shutters is unlike the others. They have been integrated with a reconstruction of the windows and their shutters. The cupboard beside the fireplace and the doors at either end the room (see next page) are designed with the same motif and with a chair- or 'dado-' rail around the room. It is possible that the walls preceded the present plaster finish with timber panelling, common at that period.

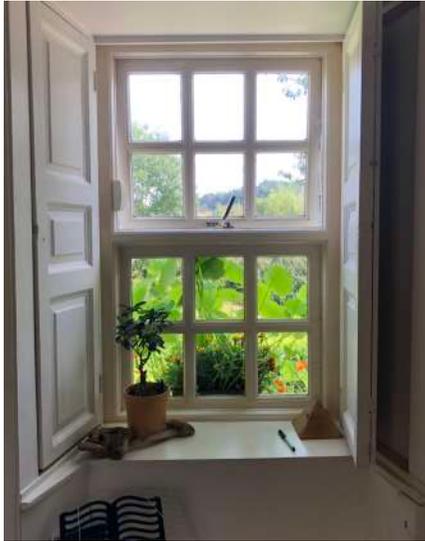
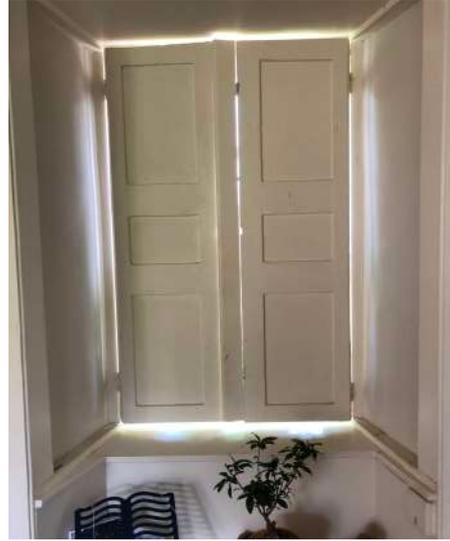
Above: After the replacement of the windows and their shutters, they were left behind in the stables block and have remained there for the last 25 years, waiting for us to think up a useful way of recycling them. Most are in better condition than this pair, yet even these could be restored without difficulty.

The dimensions across both shutters are 26 inches (660mm), and from bottom to top are each 50 inches (270mm). It appears that there was some variation in shutter size, perhaps between upper and lower floors. Certainly, those shutters which were retained, and located beside the new windows in the Parlour are 200 mm deep.

Left: Enlarged detail of the fixing for the iron bar, above, which swung across to the other shutter for security.

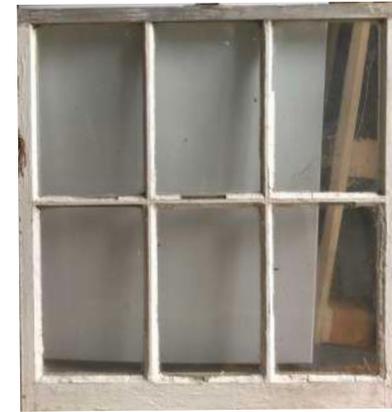
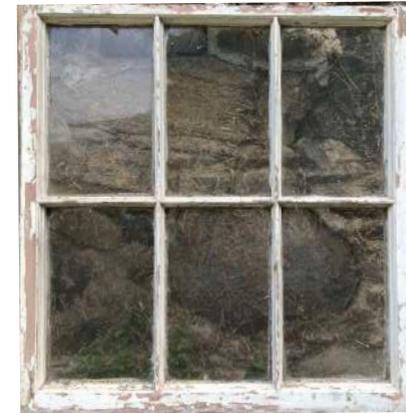
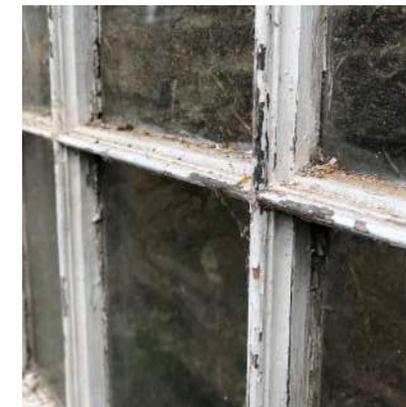
The windows shown are the lower part of a sliding sash window, this **left:** shows its exterior appearance, with very thin glazing bars with the glass held in with putty.

The image, **left:** shows the inside of the window, with very fine glazing bars shaped to a point, shown on the lower image.

The glass in the panes is exceptionally thin, and many panes are still intact.

These images are from one of several old windows kept in the stables awaiting use or exhibition.

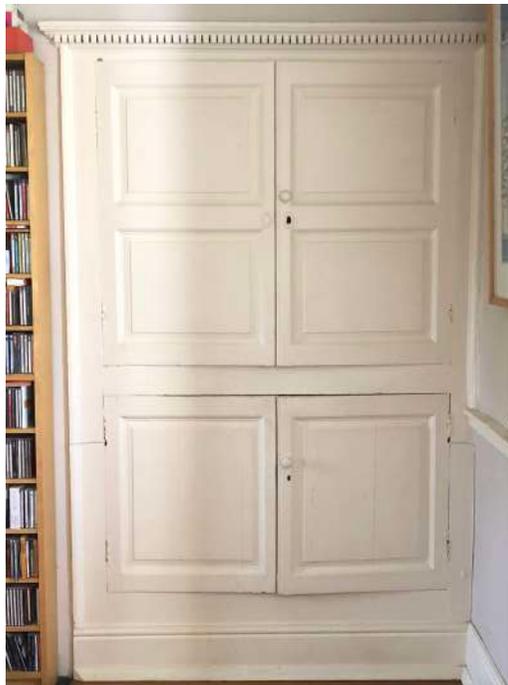
Left: This cupboard in the parlour/living room is fitted between the chimney breast and the external wall. It generates valuable storage space: records of meetings and the family bible may have been kept there. The doors have attractive mouldings, repeated on the shutters and also on the two doors of the room. The cupboard also takes up the theme with the same mouldings. It is unusual to have a singular dentil moulding at the top of the cupboard frame, which is something of a surprise in a Quaker house. The coherence of this room is greatly enhanced with the timber details. They would have given 'presence' to a room which held Quaker meetings on a regular basis. It is possible, and of the period, that the walls were panelled above and below the dado rail, before they were plastered.

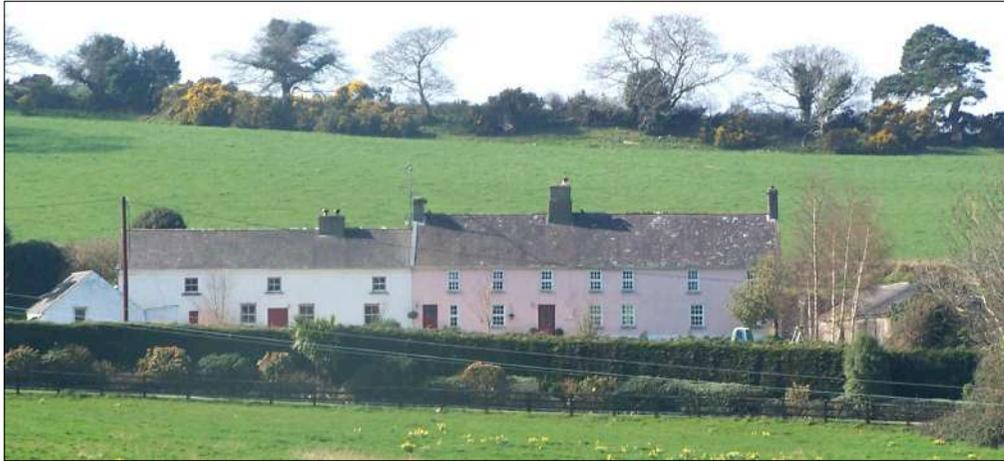
Top left: frontal view of the farmstead. The gable of the milking parlour is seen on the far left side, whilst the gable on the opposite side is the stables building.

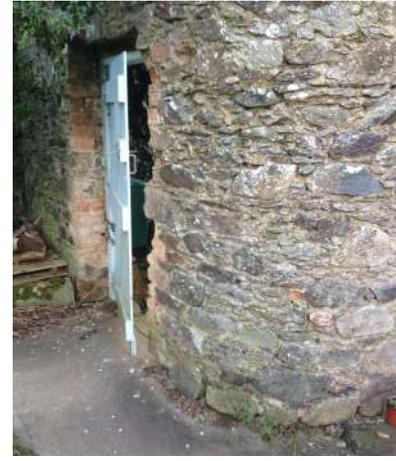
Top right: Most of the stonework has been covered up over the years. This is an outdoor wall closing off the garden to the 'dower house'. The stonework is achieved with relatively small flat stones of diverse origin, to make it easier to 'turn the corner' without cutting large stones to make the corner.

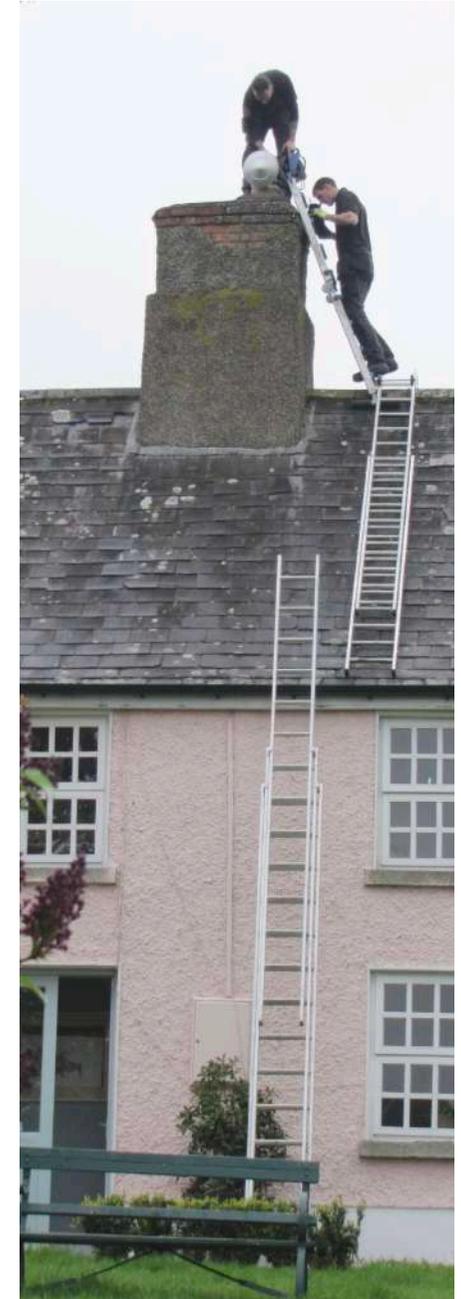
A once in a lifetime event for the farmhouse, when a chimney fire damaged the flues, but no other areas were affected. The old flues were replaced with new internal metal flues, limiting further risk of further fires in the chimney. The upper part had to be substantially rebuilt. The image shows the final attachment of the inner flue lining by the contractors, the 'Soot Doctors'.

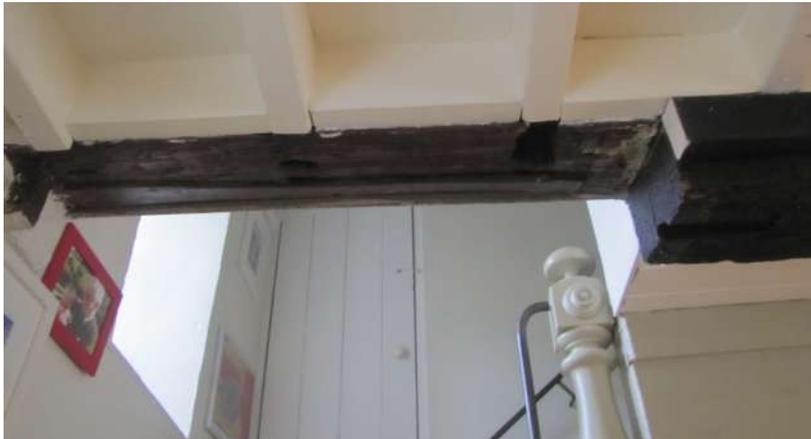
Middle left: The strange case of a dangerously-sawn key structural beam above the kitchen, presumably to gain head-height on the stairs which pass under... Nothing has shifted in our time here...

The L-shaped stair twists round at its mid point, allowing access to the pantry over the bread oven. There is an event on the way upstairs which hints at change-of-mind at some period of time. The structure of the farmhouse depends on the central stone chimneys and three massive beams about one foot, 300mm, square and spanning across the 4.9 metre, 16 feet, rooms. The stair required a significant change in one of the beams, reducing head height: it was cut away by about half its thickness over the stair...Not a great idea for the structure... However, no consequences have been noticed to date, although sleeping upstairs sometimes feels insecure. We think that the original access upstairs would have been by a fairly steep ladder stair, replaced with the present easy stair, which may have been put in when the dower house was added, to make upstairs more easy to reach for elderly parents.

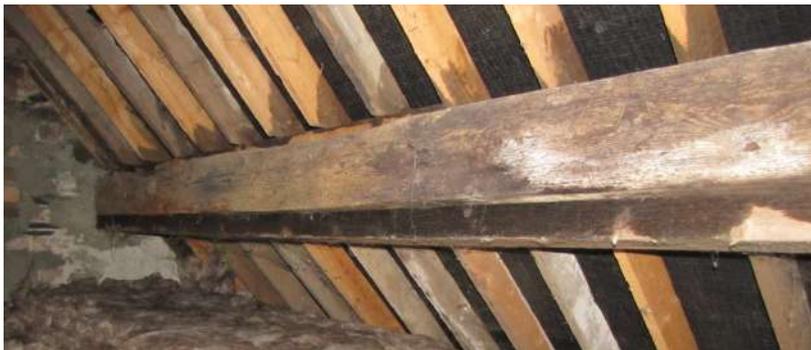
Bottom left: Up in the roof, one of the massive purlins is supporting the rafters and is supported, one third of span, by a king post truss. The room below has a ceiling with angled sides, following the line of the rafters.

The roof is slated and battened to rafters with a large purlin half-way up each slope on either side. The purlin, in turn is supported at one third of its span with a pair of collar trusses. This structure has survived, with a little help in the last century and carries a weighty slate roof at an angle of about 50 degrees. The building was re-roofed in the mid-nineteenth century, replacing a number of rafters but retaining the overall structure and placing roofing felt over the rafters before re-slating. There is a decorated feature at eaves level with bricks set at a diagonal angle: they are not visible as they are hidden behind a bargeboard and gutter, recently renewed. However the detail is the same as that used on the second farmstead attached building.

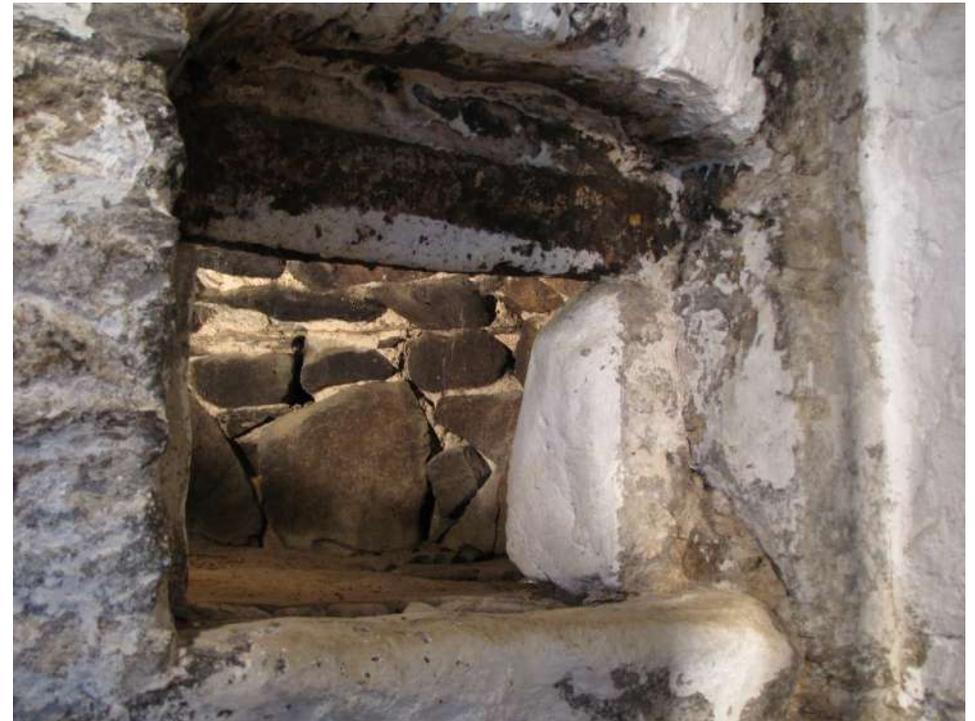
Above: The opening to the bread oven used rounded stones to encourage the easy movement of smoke during heating of the oven with fire. *"Built-in wall ovens for bread, found in some houses in South Leinster ... date from the quarter century either side of 1700"*

In Ballymurrin there are two examples of bread ovens, one from the second farmstead kitchen and the second in the new farmhouse kitchen. The first was domed in brick; the second dome was made in stone. The construction of both buildings and the dower house wing would have been carried out during the date window of fifty years, up to 1725, which Barry O'Reilly has suggested.

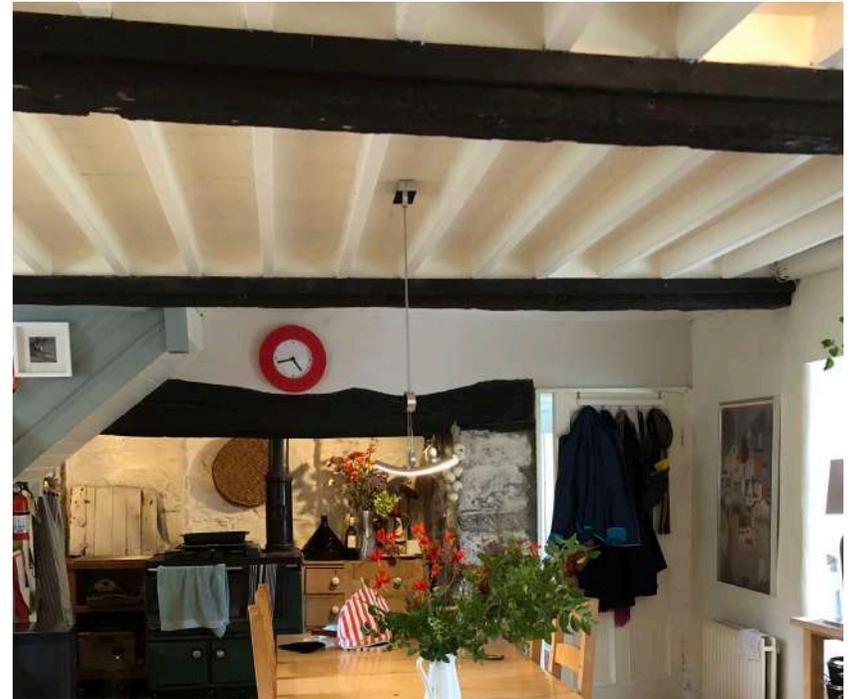
Right: This is the walk-in fireplace at the end of the kitchen. The (black) beams above are strong, spanning across the the room to support the floor above, and the heavyweight beam at the end has an interesting wavy line at its upper edge, suggesting a beam from Elm or Oak. The staircase underside is just visible on the left side, changing direction as it rises in front of the fireplace. It looks like an afterthought, perhaps to remove a ladder stair and make a more comfortable and safe replacement, and making a necessary cut-out in the large beam shown above.

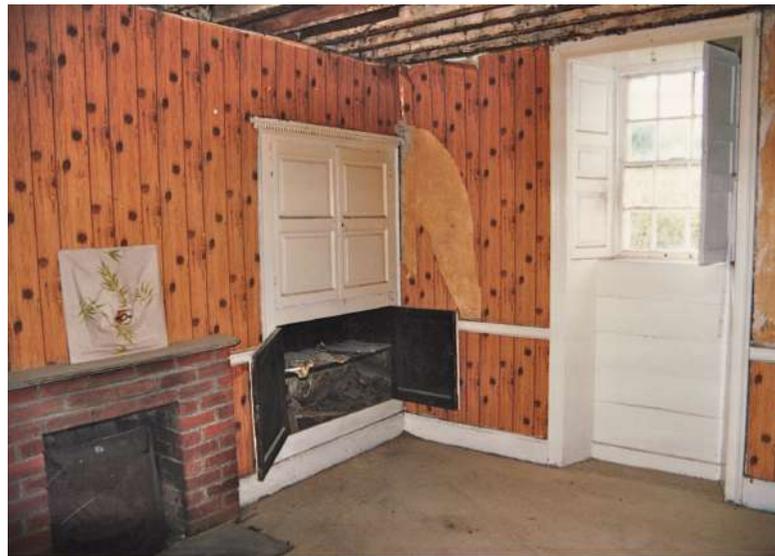
Above: The Parlour, more like a living room now, had the central feature of the fireplace, and, in the corner, a carefully-crafted built-in cupboard. **Right:** There was no original fireplace to keep and this one definitely had to go, replaced with a new fireplace and slate mantelpiece. The window shows its original form with sash window, shutters and boarded recess below. The slope of the ground determined the height of the window above ground. The ceiling has no plaster, and is awaiting timber sheeting. (Photo from 1995)

The parlour was an important room for the activities of the Quakers, who met locally every fortnight. This room would have been the special meeting room as well as the place for other meetings, family and friends, but it is likely that most conviviality would have been in the kitchen. There is a magnificent cupboard in this room which we imagine would have been where records of the Quakers were kept as well as the Bible. Some have suggested that, because it is beside the fireplace the lower cupboard may have been reserved for sheets. The ceiling was lath and plaster, but in very poor condition, replaced with sheeted timber, during the Strawbridge era. The fireplace was also missing; we replaced it with a simple opening and cantilevered slate mantelpiece.

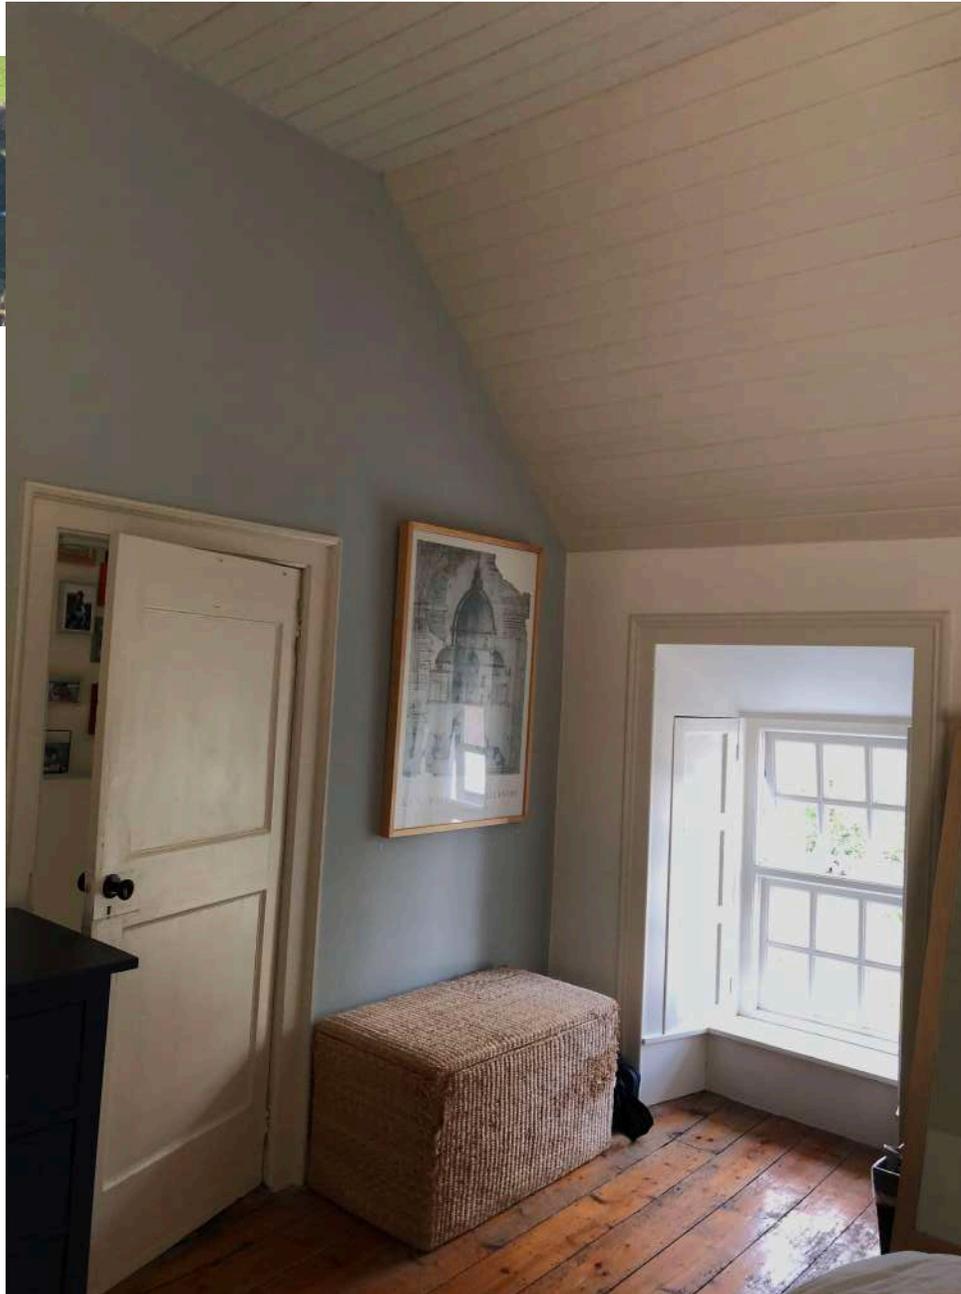
Left: Upstairs bedroom over kitchen. Sloping ceiling adds considerable height and volume to a large, presumably family, room. The ceiling is tongued and grooved, the door has original hinges, light and with interesting 1930's bakelite handles. The floor is pitch pine, decorated with woodworm (not live). Corridor leads to the Dower House extension, past bedroom and (modern bathroom). The door is behind the bookcase.

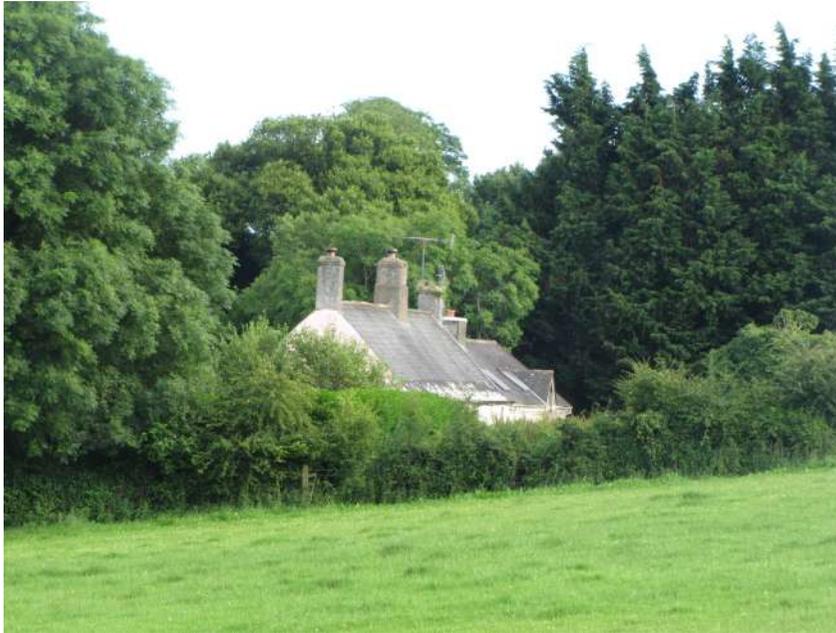
Left, upper: the farmstead sits carefully into the landscape, protected from the southwesterly winds. The excavation of the site at the back made the stonework safe from any flooding and created a sun-trap for garden and eating out

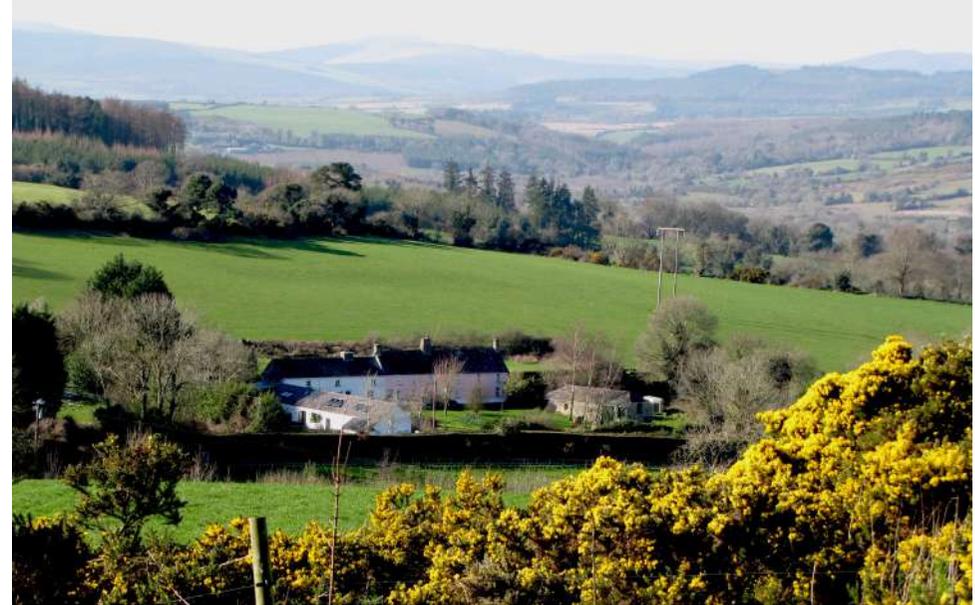
Left, lower: The back of the main buildings of the farmstead; a diverse array of what seem like arbitrarily located windows serving bedrooms, parlour and kitchen of the main house, put in over time with giveaway concrete sills. The roofing at this side of the main building result from re-roofing some time in the twentieth century. The lichen attached to the older, real, slates distinguish from the much later asbestos which, in time, will be replaced. The second farmstead was re-roofed in 1995, our first real task of repair and restoration. The roof lights were added; the door at the back, replaced the broken glass window: we intend to make a bridge across to the garden...soon.
