Ballymurrin Stories -Restoring the Quaker Farmstead The Second Farmstead

Ballymurrin
Quaker
Farmstead

General Introduction to the Second Farmstead

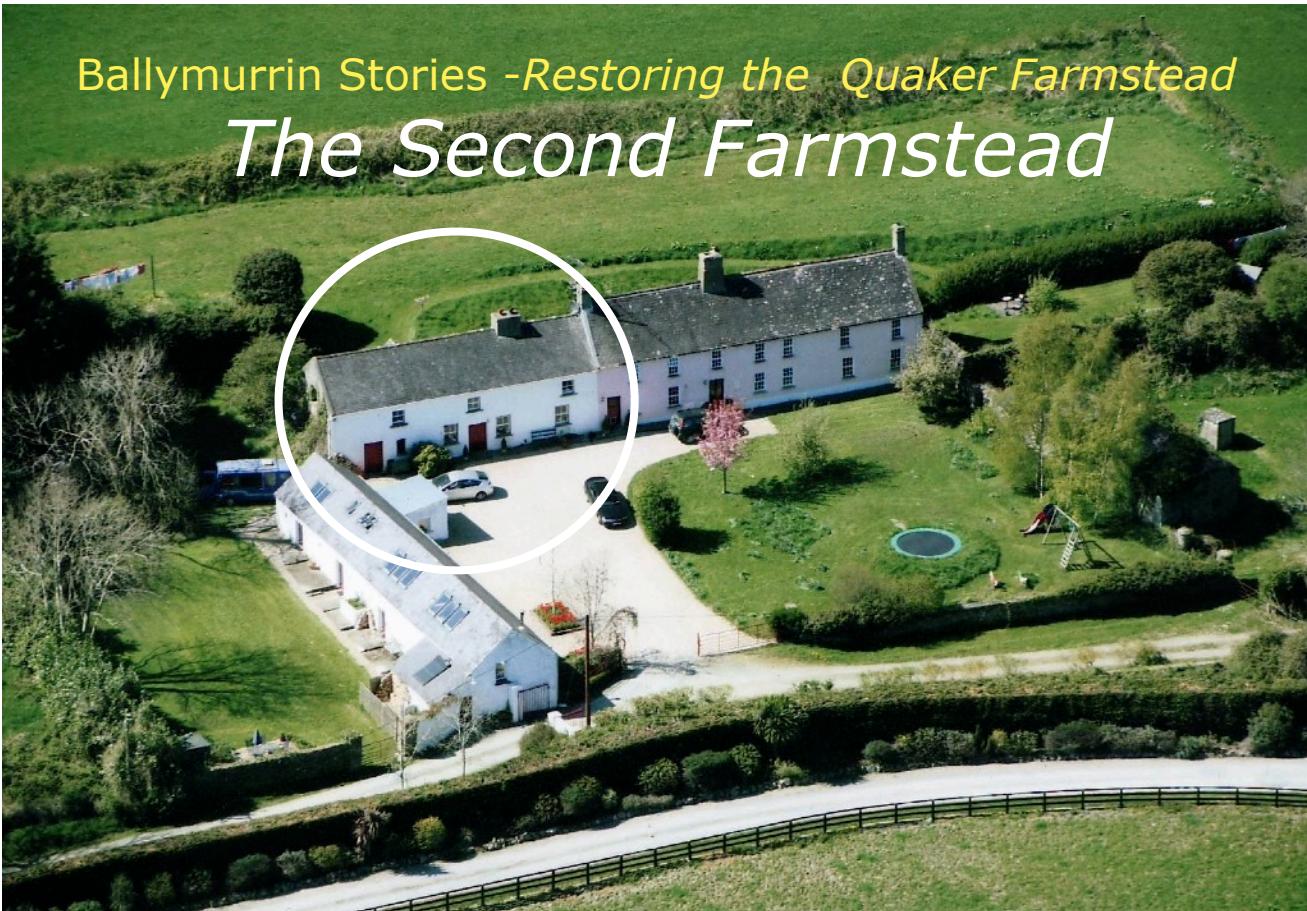
Ballymurrin Quaker Farmstead seen from above. The Second Farmstead is the white building attached to the Main Farmhouse. Ground floor included a Coach House, Forge and Old Kitchen; First Floor included two bedrooms and a loft space: one of the bedrooms was absorbed into the loft space with removal of a wall, creating a larger space, used as a studio currently.

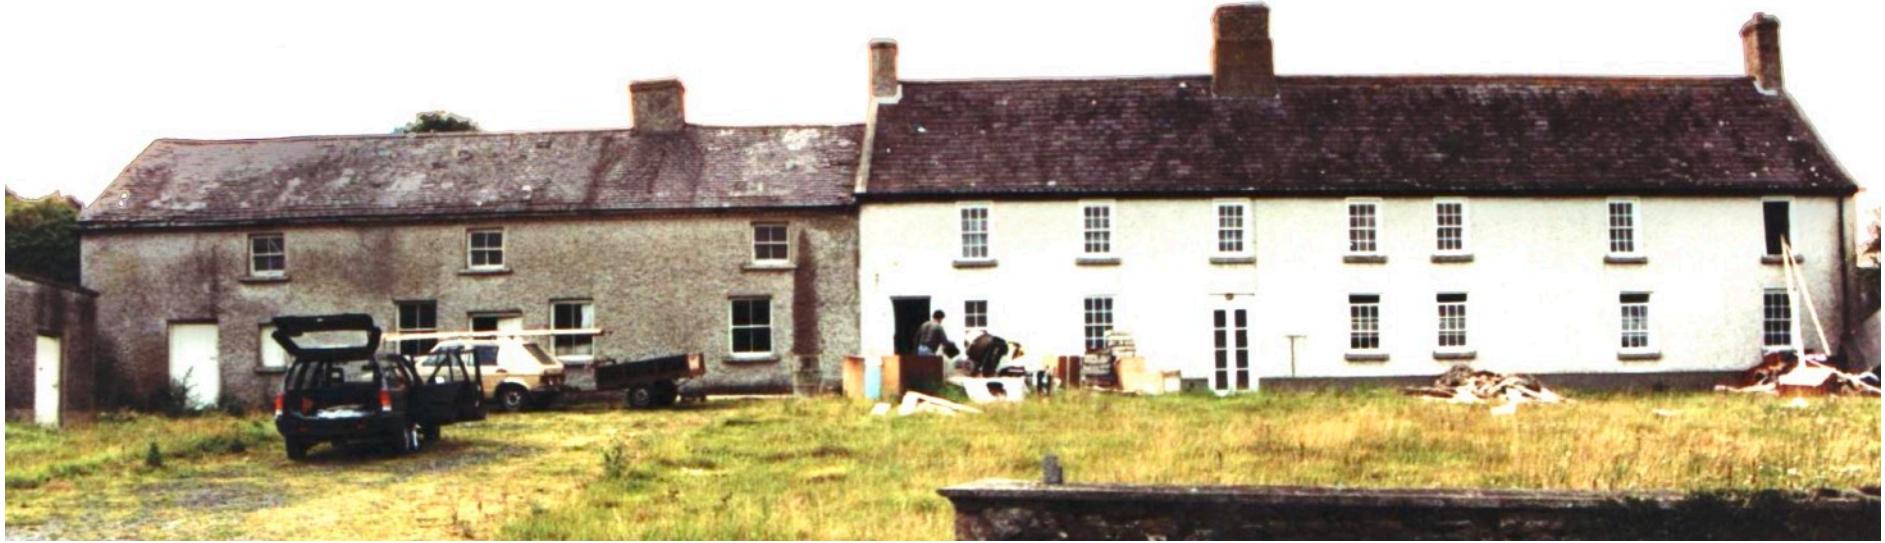
This photograph was taken, by David Strawbridge, a few years before we arrived at the house, around 1990. The building we call the ‘second farmstead’ is to the left of the Main Farmhouse. The Main Farmhouse has an added Dower House, an extension for the elderly, accessed through the main house. This image shows the original sash windows in place. They were replaced at much the same time as this photo was taken.

The second Farmstead, **above, left**, had suffered from rain damage over several decades. The window openings on the elevation have all been enlarged, each one about one third larger than the original. Evidence of this can be seen on the inside. The large ‘beehive’ chimney in this building is in the forge, a construction of timber frame and woven hazel covered on both sides with clay, about one foot, 30cm, and covered inside with cow dung to deter accumulations of soot. It is difficult to be decisive about age for this building, but likely to be from the 1670s. The first floor incorporates a bedroom, (upper window, right) and a large loft area, originally smaller until the stone dividing wall was demolished, and the floor levelled. The date of this change is written in the concrete - “P.O’S 1935” (Patrick O’Sullivan was the owner at that time). We adapted the upper level as a studio with new Velux roof windows behind and inserted a bathroom for the ground floor bedroom at the far left end. There was a door (located with a white line on the elevation) which was closed off, perhaps when the Main Farmhouse was built.

The ‘Dower House’, for elderly family, occupies the two bays of windows on the right. The symmetrical front and central door has a modern replacement; the original door was solid with a fanlight above, rectangular with five panes. The side door to the kitchen in the main house, centre above, was an addition also of relatively recent times. This photograph shows the original sash windows which were replaced with hardwood using the same subdivision panes but with fixed light and top hung opening on each.

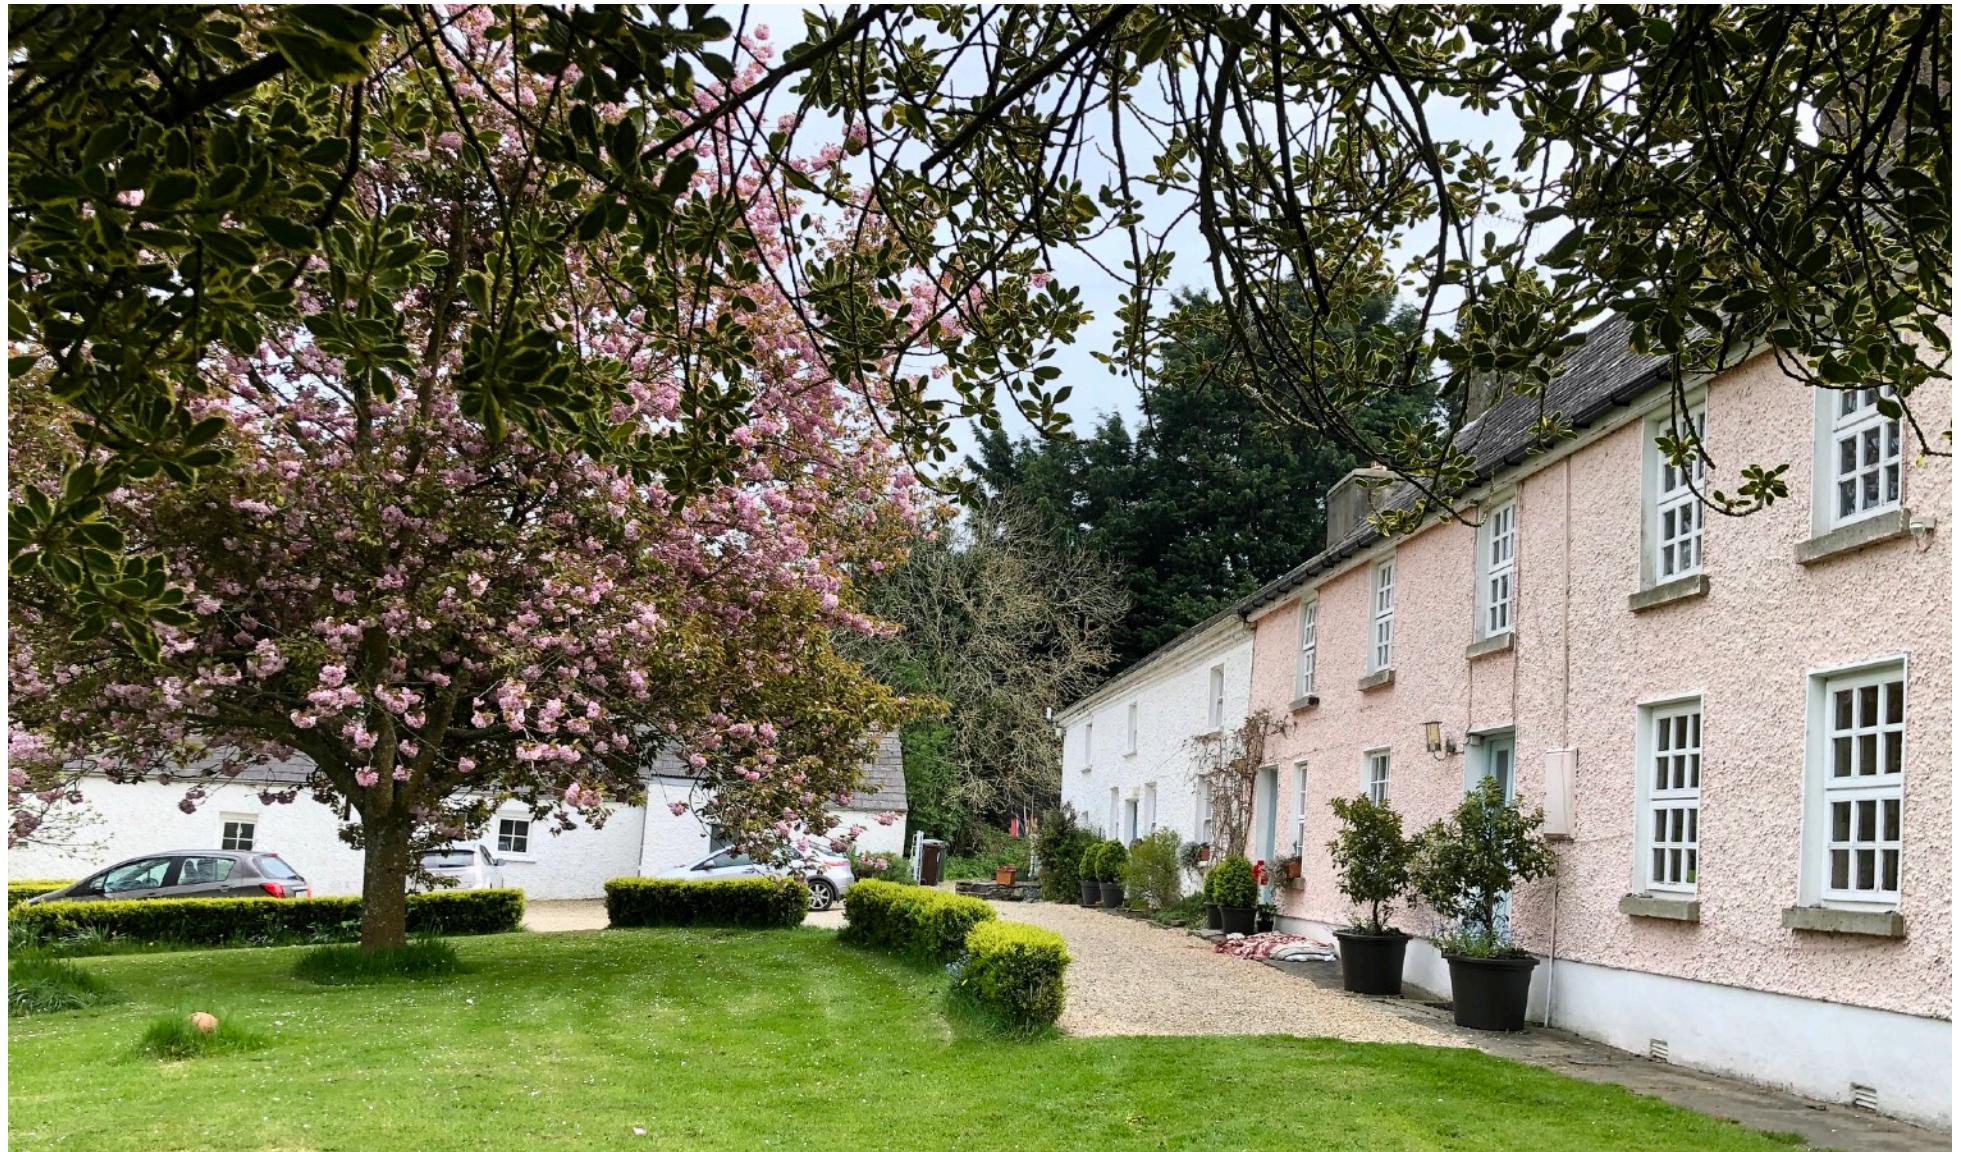
Looking at the long elevation, with the Main Farmhouse frontage in pink, with a five bay symmetrical window pattern . The sash windows were replaced with outward opening top panes, about 1990, when the Strawbridge family lived here..

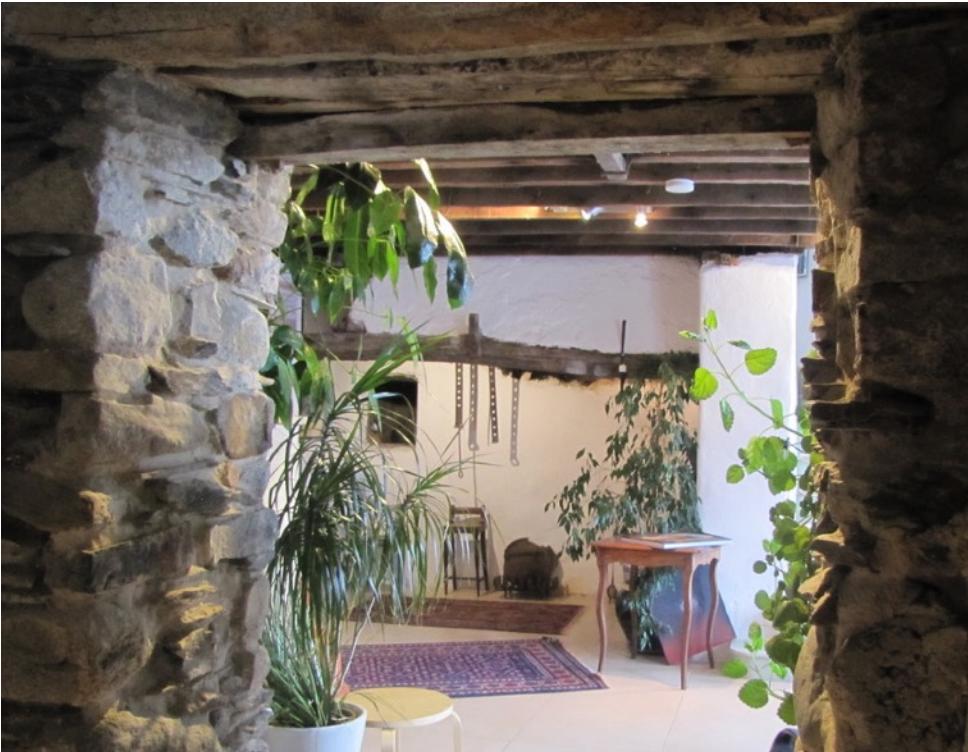
Above, Left, Seen through the opening to the adjacent Coach House area, a single beam holds up the structure inside, created from a timber pole structure rising up two stories. The structural wall was filled with woven hazel, clad with clay and coated on the inside, with cow dung, to deter the smoke from settling on the clay structure.

One of the most important interior elements, the ancient **beehive chimney**, was in good condition although its passage through the roof needed repair. Minimal intervention in the past ensured that this astonishing evidence of the farrier's /blacksmith's workplace, the **Forge**, survived intact.

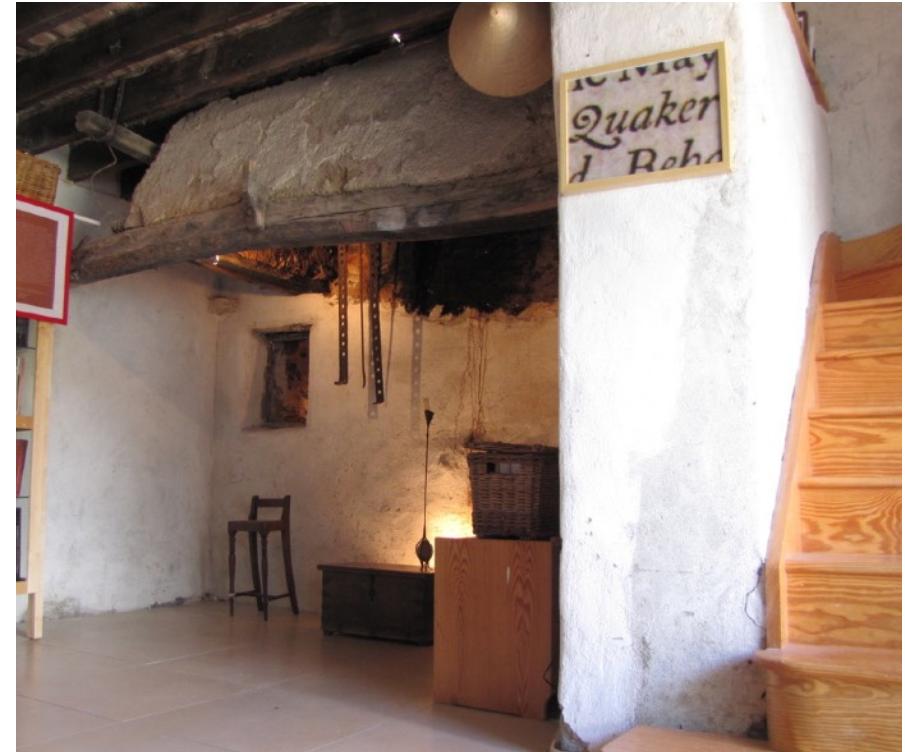
The loft was accessed by ladder in an open hoist area. The opening now accommodates a stair within the space, **above, right**. The images show an opening within the chimney, which was a bread oven. It was opened into the forge when the opening old kitchen chimney was closed off. Whilst it was not used as an oven in the forge, it would have been useful for handling and placing hot steel, away from the fire. The space outside the chimney and between the wall of the room is likely to have housed a 'great' bellows for the fire. The compacted floor we replaced with a tiled floor with underfloor heating. The joists span across over 5 metres. All were intact and still support the upper floor loft area.

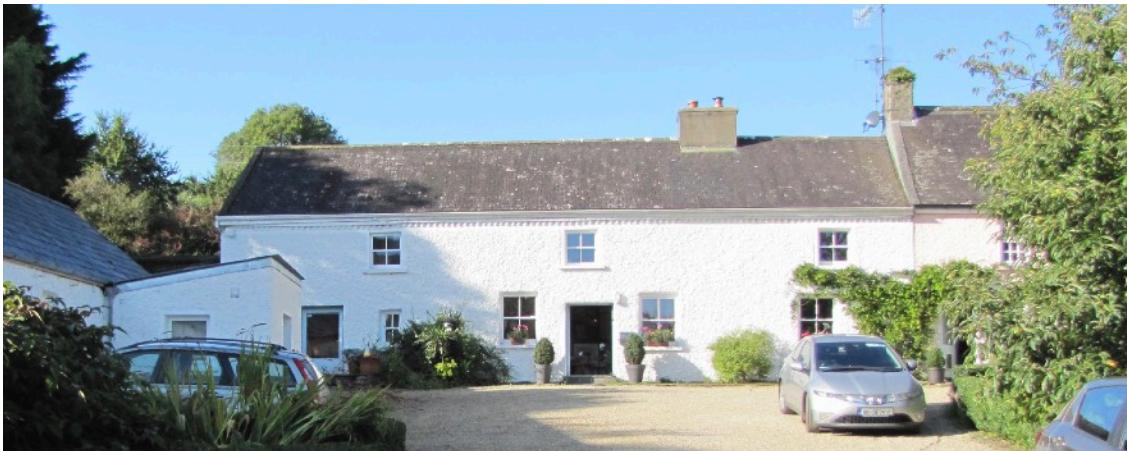
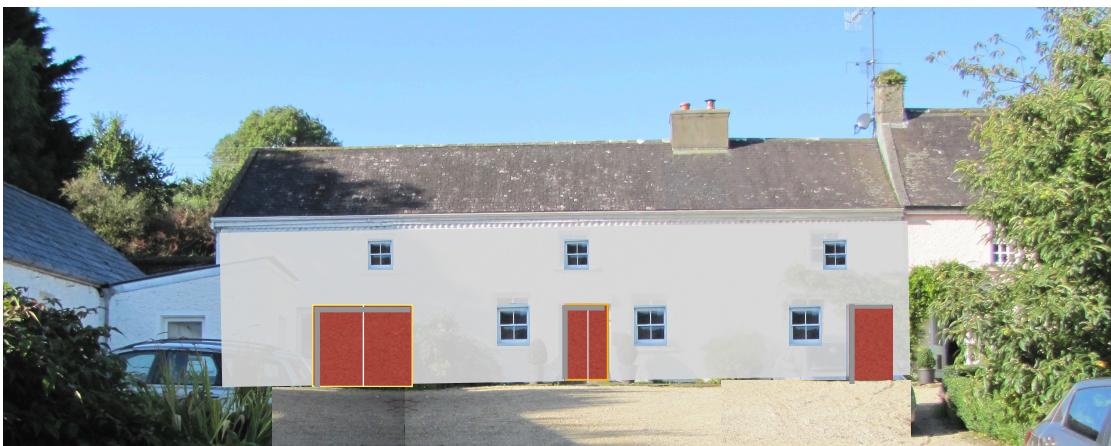
The Second Farmstead, outside

Above: Current condition of the Second Farmstead

Below: Likely appearance of the Second Farmstead in its early life, based on evidence inside, with Coach House doors, smaller windows and original door to the old kitchen.

The image, **left**, shows the current appearance of the second farmstead. We have used the evidence from inside the building to generate an image, giving the likely appearance of the building at the time it was built.

These changes, affecting the elevation, were as follows:

Windows were enlarged at a point in time, perhaps in the mid nineteen-twenties. However another change occurred with the closing of a larger opening to reflect a changing use, for animals. Previously it had a larger opening suitable for a coach house or for agricultural machinery.

The evidence for this from inside is a stone relieving arch, above, spanning about three metres, (ten feet). With support beam just below, which is intact and in place. About half of the opening was built up in stone and adapted with smaller doors to suit its use for animals.

The smaller window beside the animal entry on the current photograph was originally a loading opening for sacks of grain to be lifted to the loft through a floor opening. It had a solid timber hinged door, replaced now with a sash window.

A further change, not visible from outside was the closure of a front door to the dwelling part of the building, the kitchen, which had upstairs access to a bedroom. This door is shown on the image, **left**.

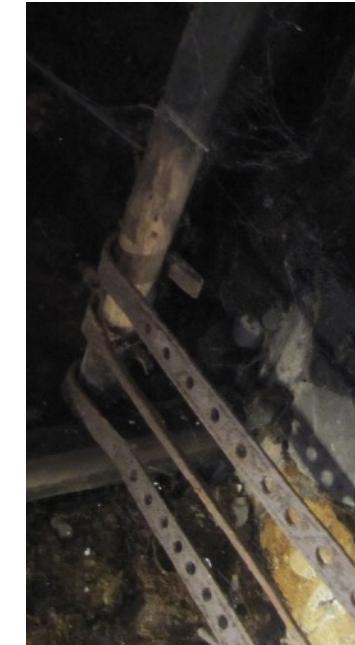
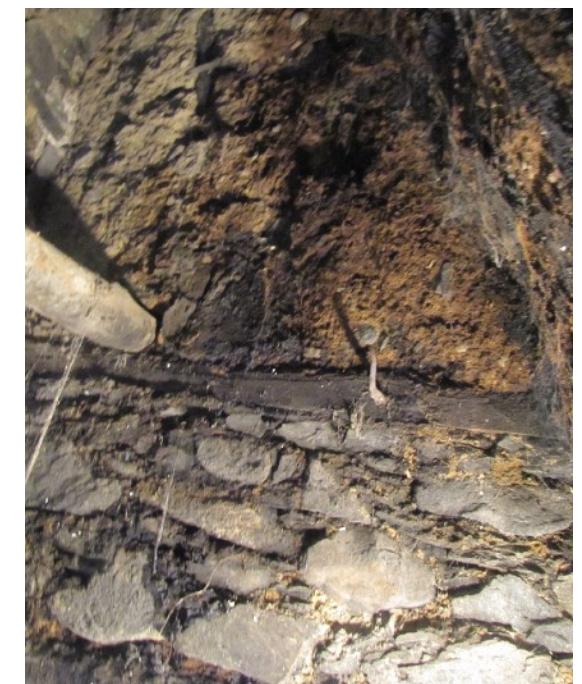
Inside the beehive chimney. The stonework is shown **above, left:** one end of the chimney is carried up in stone walling to about 2.5 metres (8 feet). From this base, the structure rises over two floors, and through to the chimney stack on the roof. The back of the chimney, just visible, **top left**, is the rear stone wall, between the forge and the old kitchen. The rear wall is shaped to draw smoke up the chimney at the back. The side and front walls rely on the timber structure for support. The clay and wattle infill is about 30cm (1Foot) thick. It is not possible to see any attachment to the back wall.. This construction appears to be original and unchanged.

The beam, visible in image **upper right**, known as "the randle tree" is built into the walls at each end. It was used to hang, for example, containers of water or cooking over the fire, which were hung on the "rack and hook" shown **above and right**, which allowed the height to be adjusted. These implements were found hanging on the beam

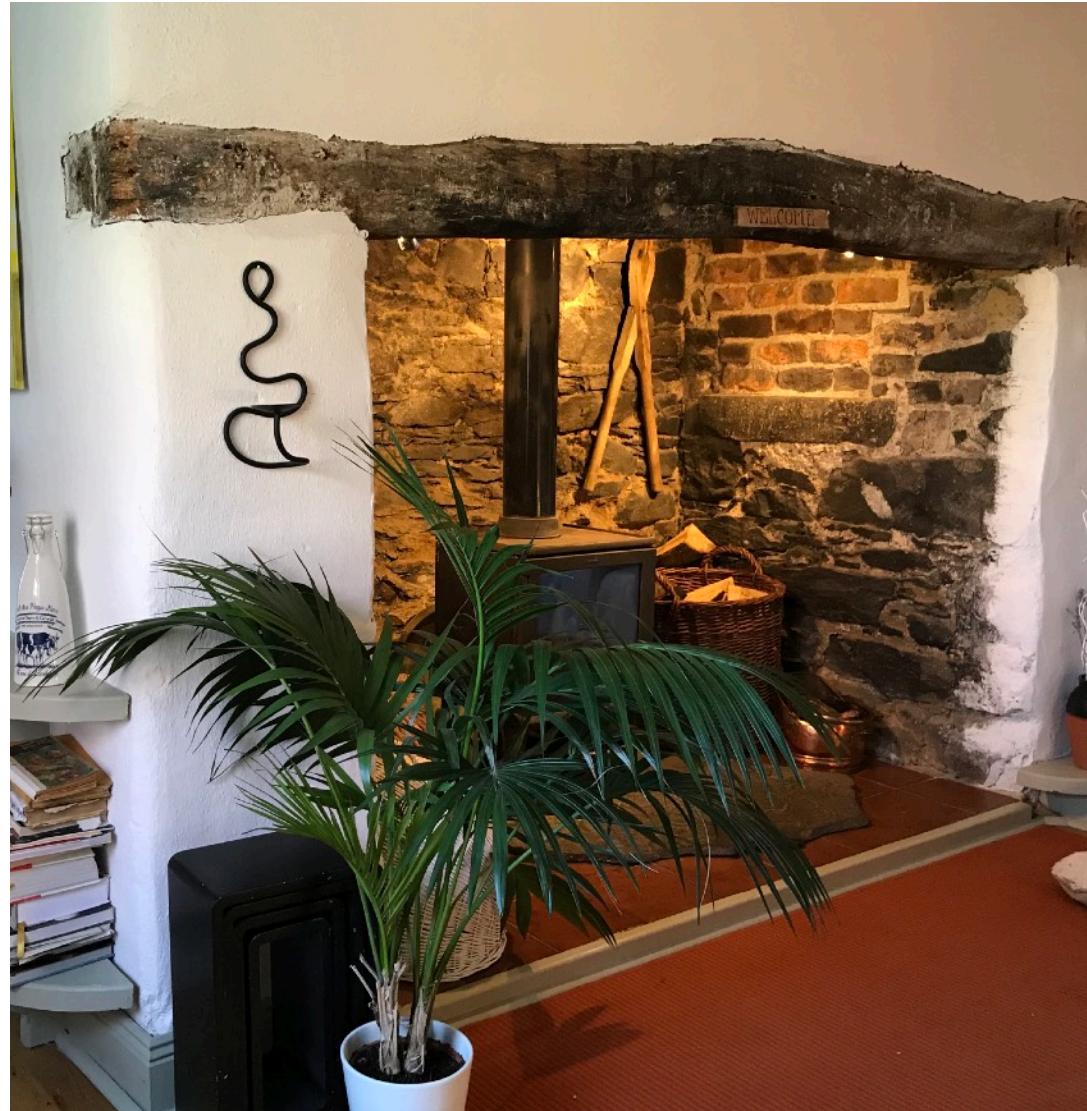
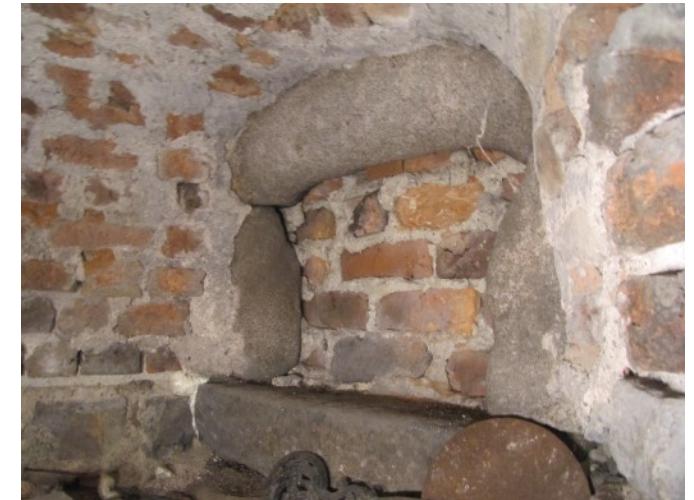
We lived in Ballymurrin for two years before we discovered this extraordinary fireplace. Curiosity drove Delphine to poke her head where there used to be a small opening for a modest fireplace.. Beyond that was a much larger space. Although it had been filled with rubble we were able to identify the beam supporting the opening, hidden behind lime and paint. Careful removal of stones below the massive lintel exposed a large fireplace not viewed for some 200 years. We put in the stove and a new chimney liner, placed a large piece of leftover Liscannor slate under the stove, kept the authentic 200 year old soot on the walls and out of a curious space we retrieved the 'Old Kitchen'.

recovered the original bread oven. The blocked up opening in the side wall of the fireplace is visible, **left**, and from inside the bread oven, **above**, it is possible to see how the closure was made. When the fireplace was closed the bread oven was re-opened in the Forge next door and put into use as a 'cooling' place for hearth-bent iron. In the image **above**, the brick work sealed the opening but the surround of the actual opening was retained. The curious rounded stones, it has been suggested, were placed around the opening to guide the smoke during heating of the oven to curl around, and out of the opening.

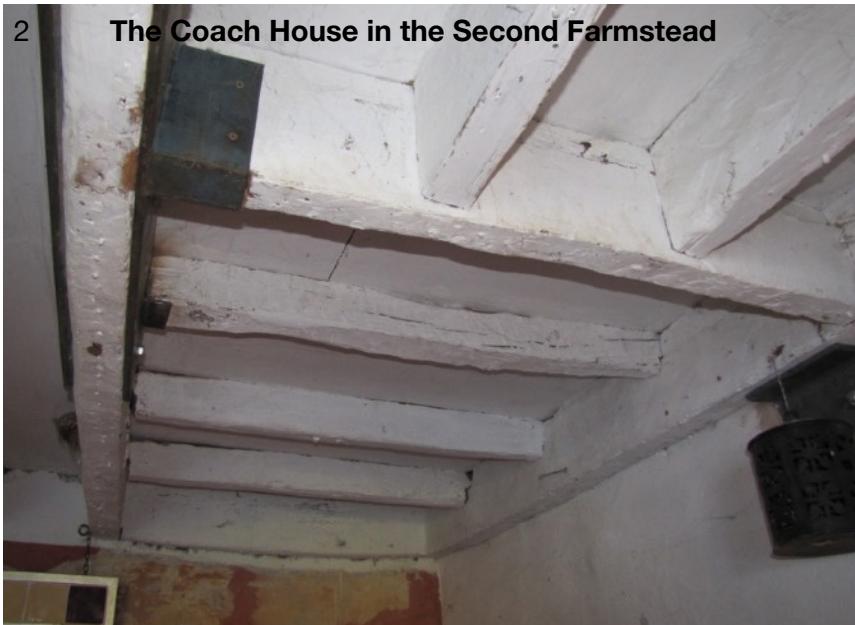
Left : part of the floor structure showing essential repair. Steel plates were used to clamp together the fractured beam,(left of picture). A 'shoe' was attached to the steel plate to carry the end of the cross beam. The three short timber cross-beams closed the opening, used for a stair or ladder, until it was closed.

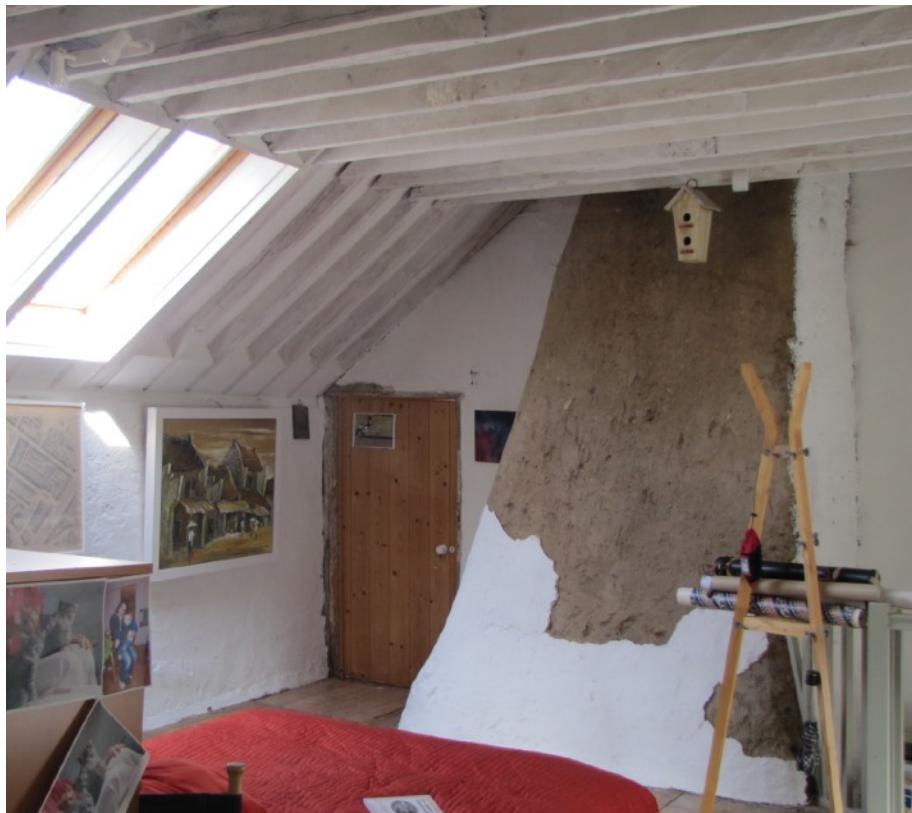
Above: This part of the loft space is above the forge, hence the presence the large beehive chimney passing through, against the wall and passing through the roof into a chimney stack. At some stage the clay and wattle surface deteriorated. It has been unchanged to show the structure uncovered. The clay was strengthened with grass which is visible, and the lime covering with horse hair strengthening can be seen in this part and the rest of the room. The Velux roof windows compensate for the small windows at this end of the studio/loft, and now generate strong light in the loft area.

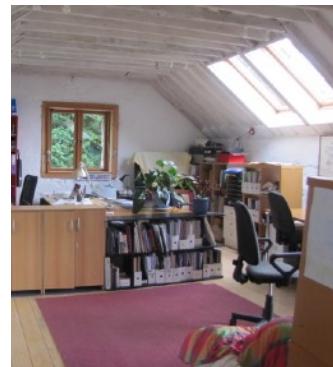
Left: The opposite end of the loft faces due South.

- The whole of the roof had to be replaced, after years of neglect. However it was possible to retain about 30% of the original roof and carefully set the old timbers back on new wall-plates
- The window at the end had been closed up with stonework some time ago. However it was possible to use the intact opening to fit in a window, (4 ft x4 ft) facing South, to bring light into the room along with the Velux roof lights.
- The flooring above the Coach House was severely deteriorated and was replaced with red deal sheeting. Salvaged sheets were re-used as replacements for the area over the Forge

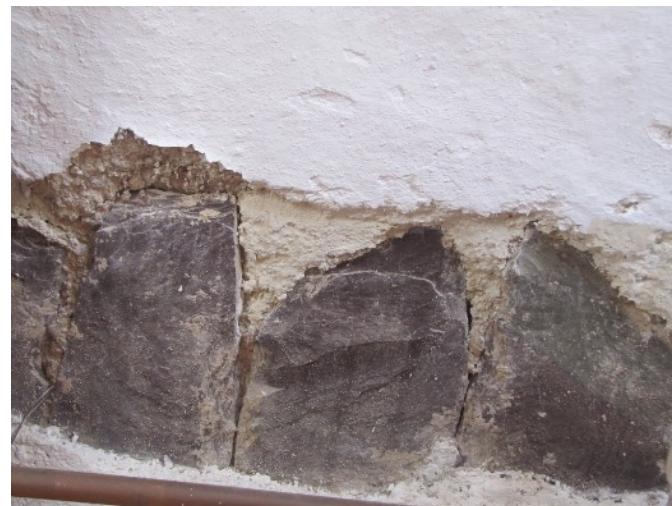
Left: An unusual detail which related only to the loft area: a line of slates bedded in lime plaster surrounds all external walls.

It would appear that the floor had been used for drying barley and other grains. It can be surmised that the slates were acting as a protection from damp in the walls and possibly rodents if the grain was spread on the floor to dry between the walls.

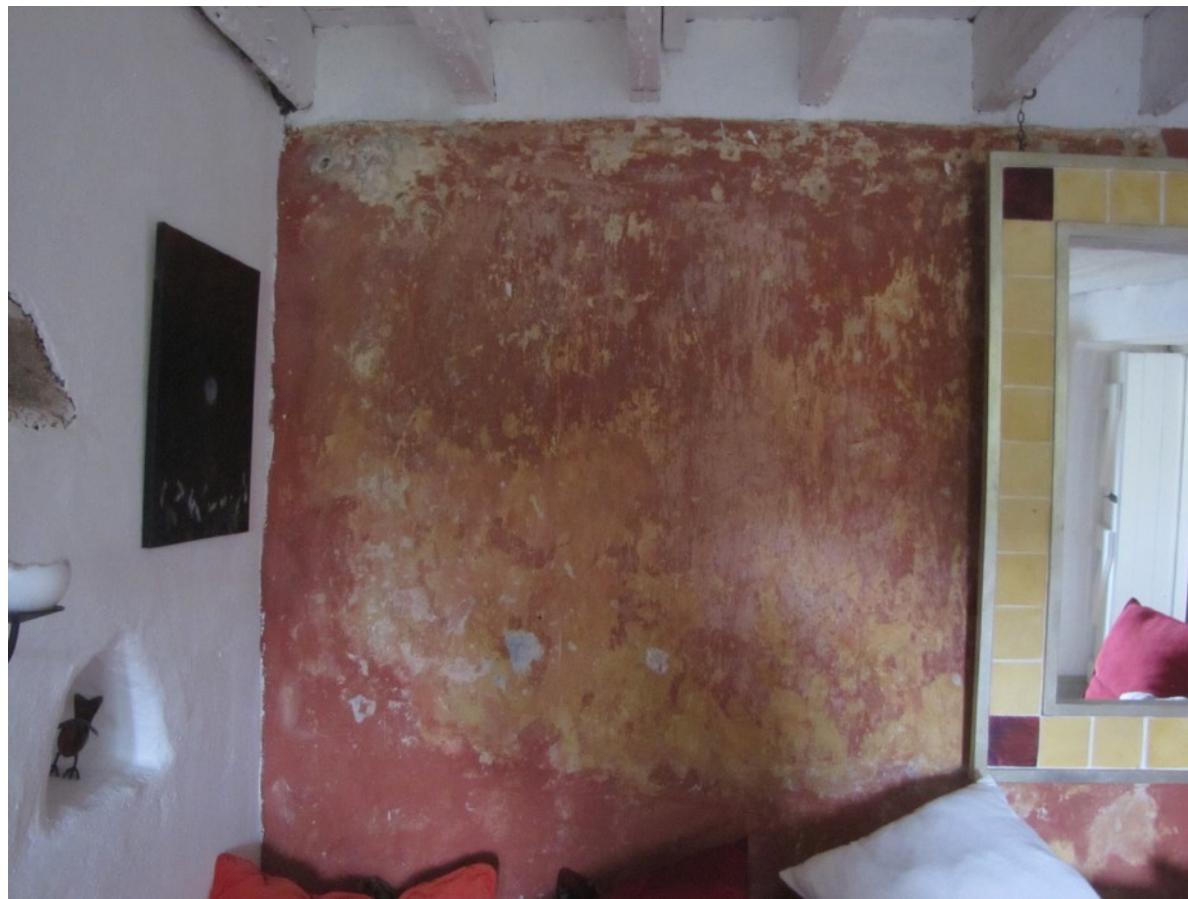
Above: This wall, in the old kitchen, was found with traces of several layers of distemper, a chalk-based paint, mixed with size. There are about eight colours ranging from deep red to pale blue. The surface is easily brushed off, despite which, this example survives. We were advised to protect it, 'by putting a settee against it' which has been successful, so far. Many of the other wall surfaces have not survived. However, when we 'borrowed' an experienced lime plasterer on loan from a Wexford Company, we were able to retain islands of distemper paint by asking the plasterer to 'feather' the plaster around those areas of paint which were still viable. The wall partly shown, **right**, is an example of how successfully the walls were restored, whilst keeping the historic coats of distemper.
