Ballymurrin Stories -Restoring the Quaker Farmstead

1: The First Farmstead

Ballymurrin: The first Quaker Farmstead in 1668

The First Farmstead - revealing the hidden building

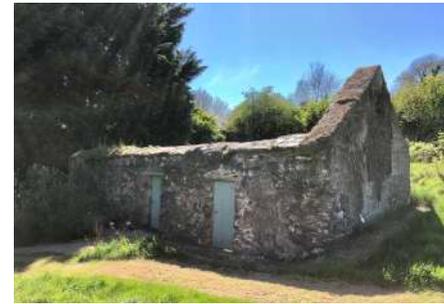
Top, Left: First farmstead in ruined condition. **Top, Right:** The second farmstead. **Above, left:** The cowshed, a long building, making one side of the farmyard / kitchen garden, now converted to Milking Parlour dwelling. **Above, right:** Ballymurrin in its landscape.

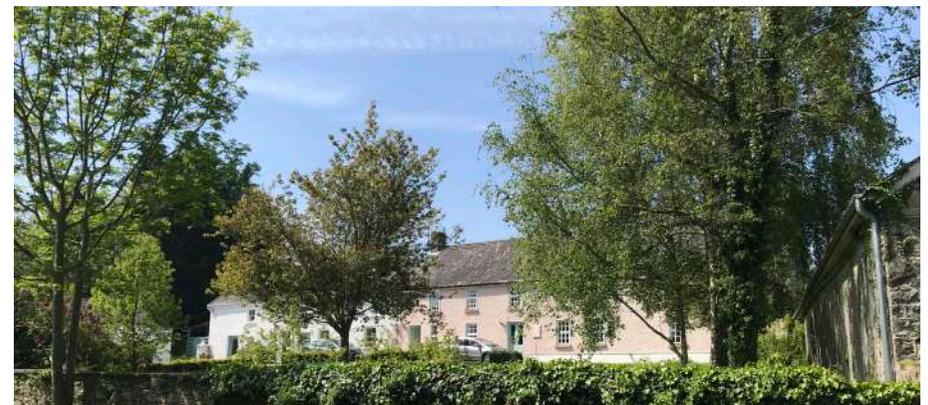
Below: Immediate right in picture is the stables facing the farmyard/ kitchen garden. Frontage, pink is the main farmhouse with its 'dower' house. The house is attached to the second farmstead, painted white

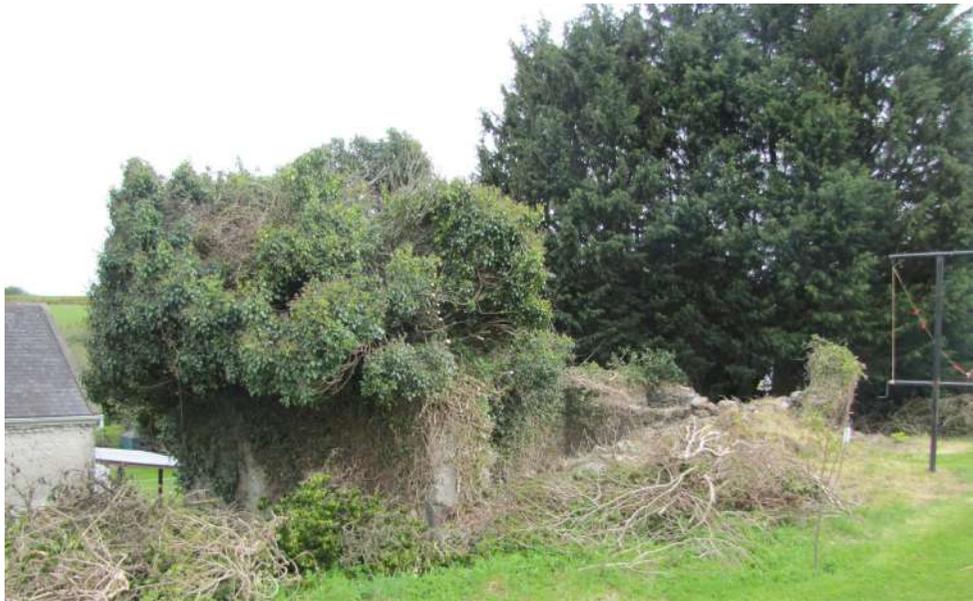
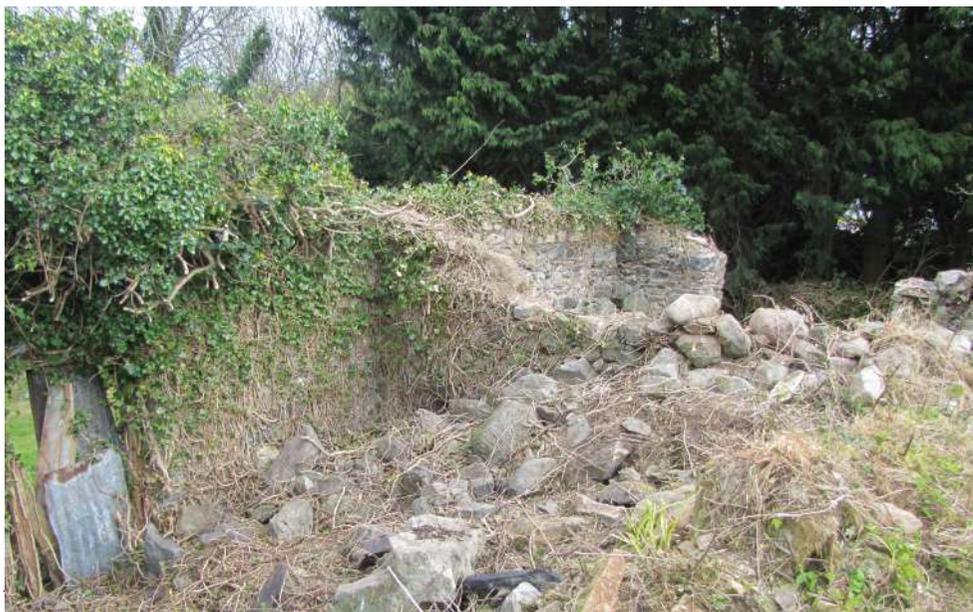
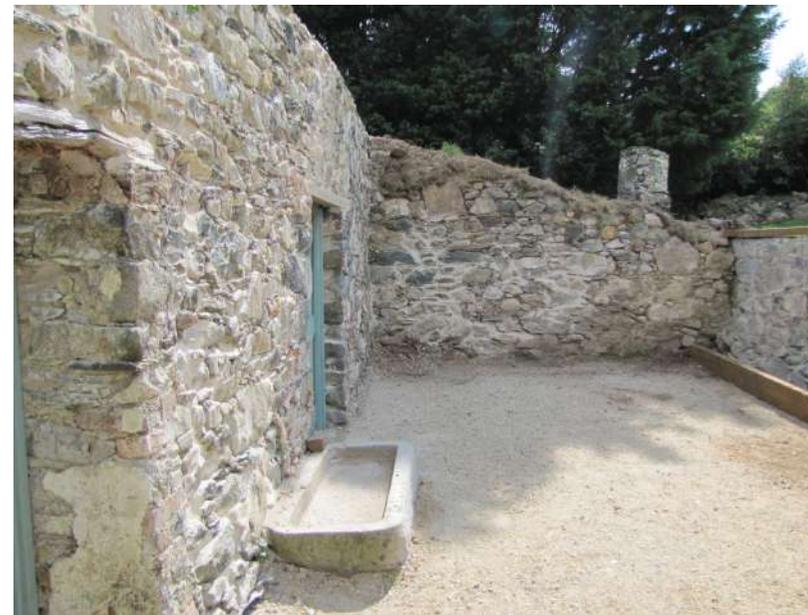
Above, and below: The condition inside the shell, below, left a massive job, cleaning up centuries of decay, with ivy adding to the serious threat of disintegration.

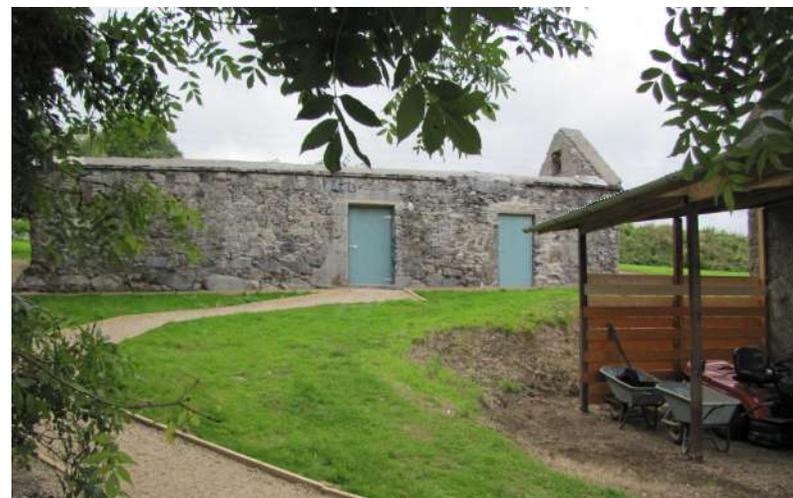
Below:
The main space in the building was for animals. The openings and walls were carefully pointed with lime as necessary, with repairs to lintels and a gravel base. The dividing wall at the far end separates the space from a cart shed accessed from the gable end. The remnant of a clay and turf wall above the stonework probably went up to the roof.

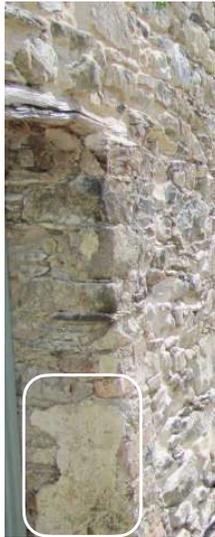
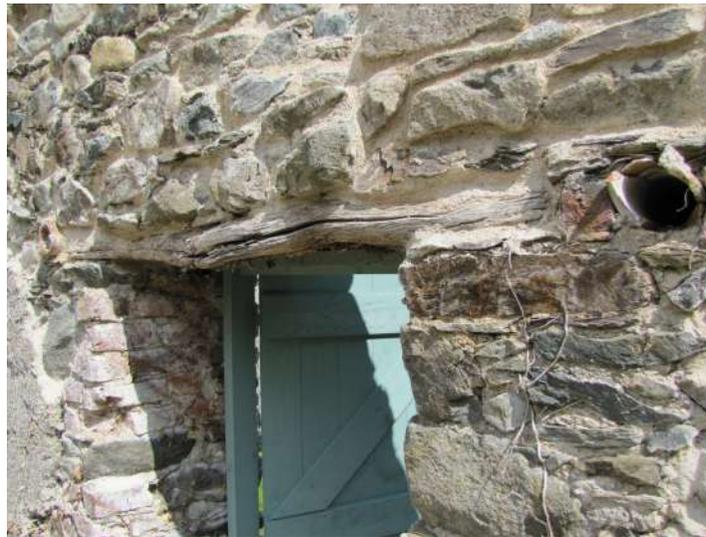
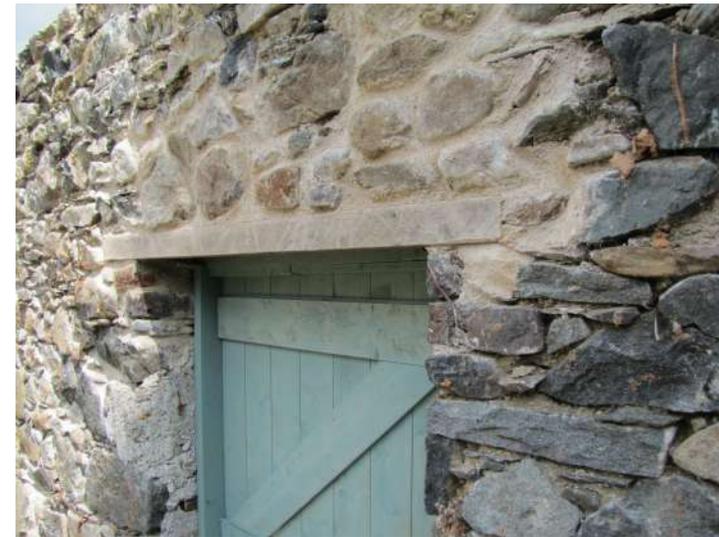
Above, The jamb of the doorway carries a remnant layer of plaster, outlined, indicating that the the space at this end was inhabited.

A line of brickwork (below the gravel surface) points to a wall or partition division between the residential part and the animal house.

Lintels were in poor condition, needing replacement, although it was possible to save one of the doorway lintels **above left**, reflecting centuries of use, and to make repairs to the other lintel, and the stonework which collapsed, **above right**. Note also the clay pipe fixed into the wall as a channel for ventilation in the animal house.

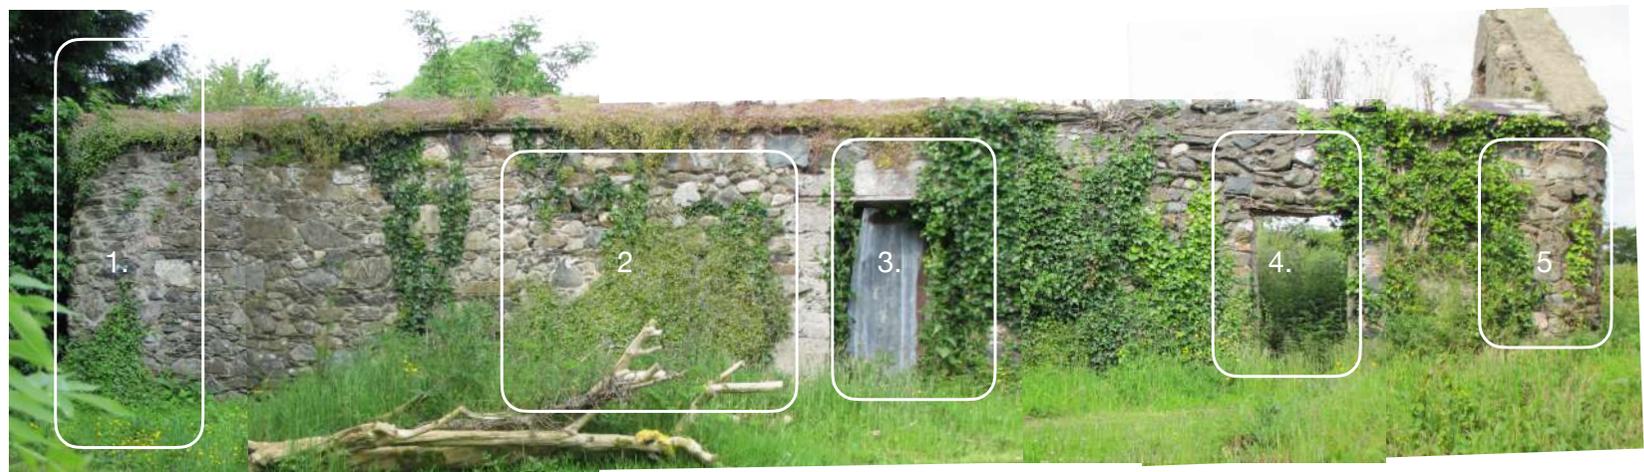
Below: elevation of the first farmstead prior to taking off new growth after removing the ivy. There were several issues to be dealt with; the rounded corner was in danger of collapse as a large portion had fallen out. This was undertaken as an emergency measure before the overall rescue could be done. The stonework was deteriorated in area 2, where a very poorly repair was made some time ago. The doorway in area 3 needed a replacement lintel, shown above, The doorway in area 4 needed only limited repair and the original lintel was retained, see above. Area 5, the rounded corner needed limited repair.

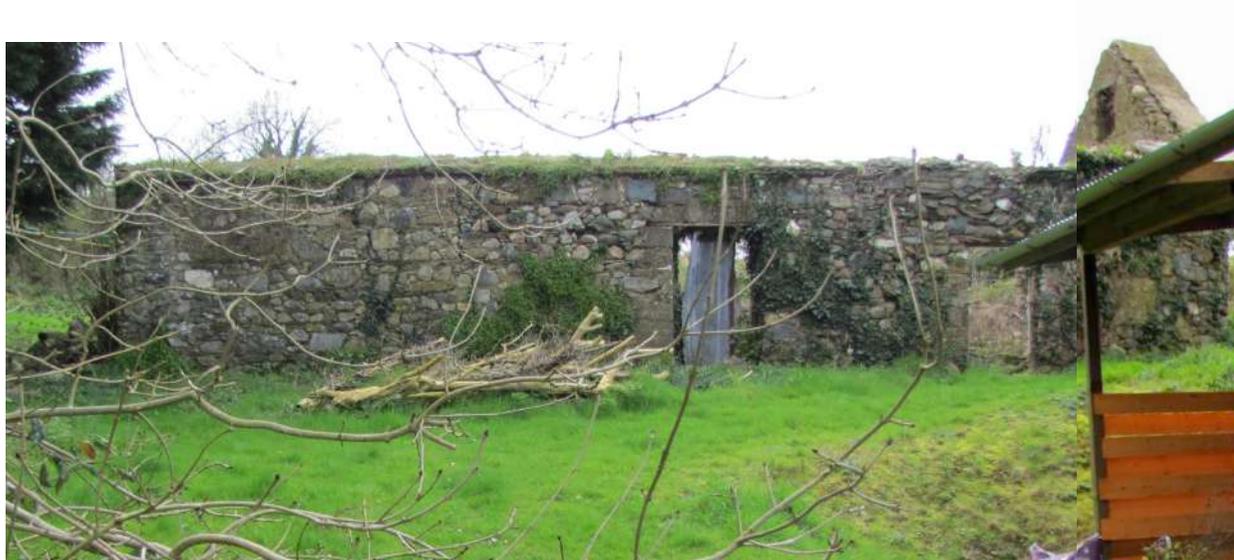
Left: After the ivy was removed, the condition of the walls, inside and outside could be ascertained in order to prepare for a thorough repair and pointing of the walls. This was carried out by Eamon Delany, stonemason, who removed all the collapsed stones away from the building, to level the floor of the building and finish with gravel, to repair and replace lintels and to make a level finish inside.

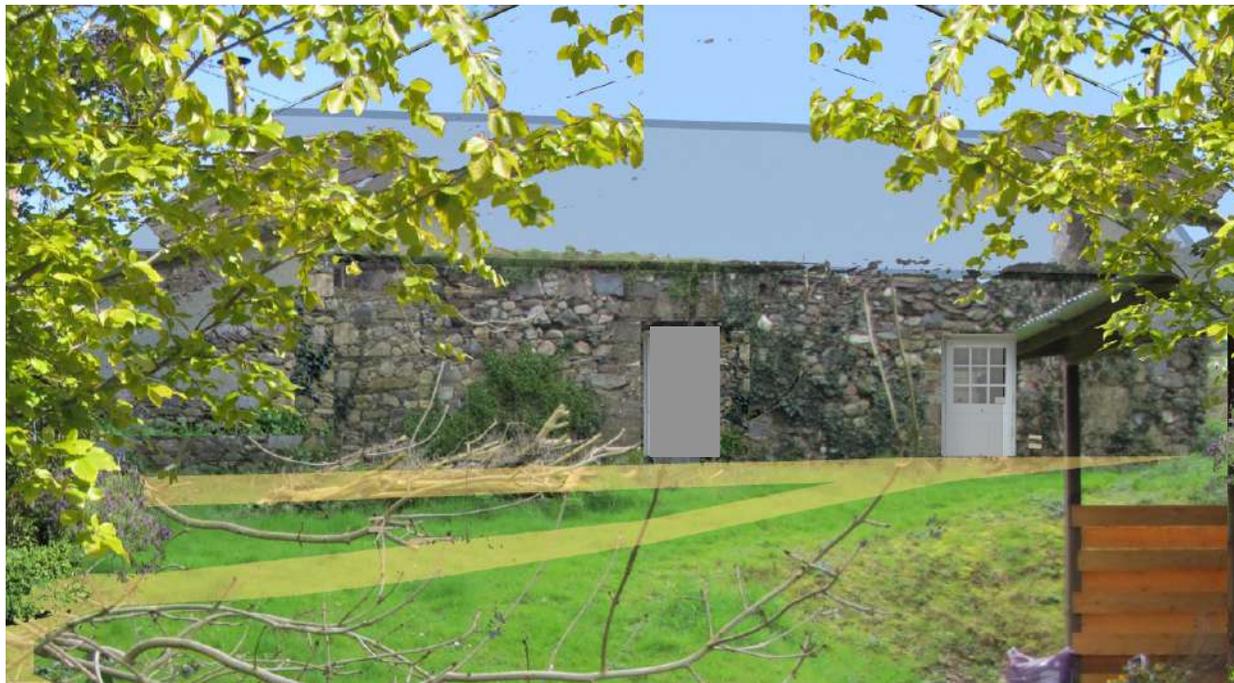
Left: the image is a diagrammatic suggestion of how the building could look with a renewed roof and doors, although it is not intended to do more than consolidate the stonework of the building to show the meaningful structure of the walls and the enclosures that they made for family, animals and carts, as a modest version of a farmstead building. It would allow the farming of over 200 acres to be carried out effectively. It was soon after completion that the building was occupied by the first owners, Ambrose and Anne (Eves) Judd, who married in 1667, and produced their first child, Robert, who was born in the house. His birth in 1668 recorded in the Quaker record.

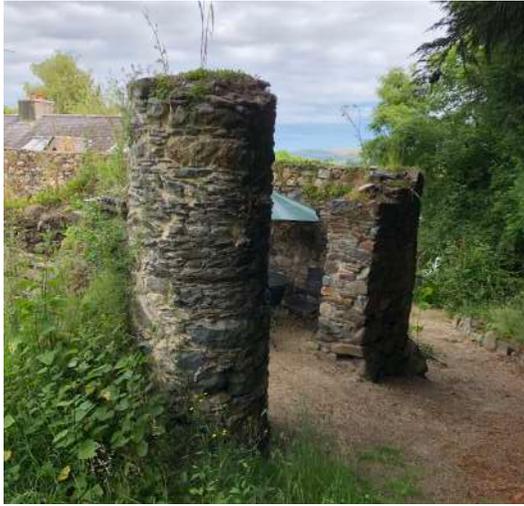
Left: This is the entrance to the cart shed at the gable of the farmstead. The gable end opening collapsed shortly after we arrived in Ballymurrin. ... The tall pillar is a mystery, possibly a gatepost to the fields above.

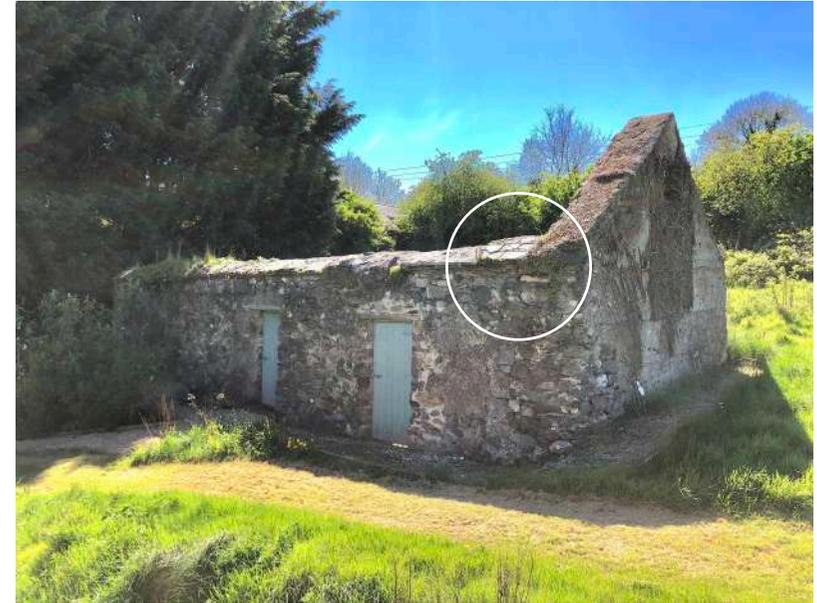
The stonework of the building will be secure for some time...until the ivy grows again. This gable end still has the dried out ivy climbers, now used to help wisteria to grow on the gable. The material used in the gable is part poured-and-shuttered concrete, undertaken some fifty years ago. The circled area is one of the clues to the roof: there are a few slates remaining, attached to the eaves, confirming that the roof was slated.

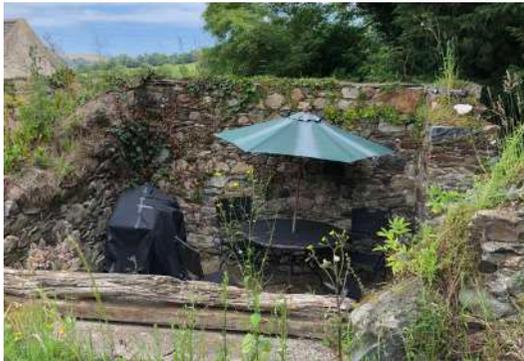
The image, **left**, shows what could be kept from the collapse; in the foreground is one of the timbers which supported the gable seated on the top of the wall.

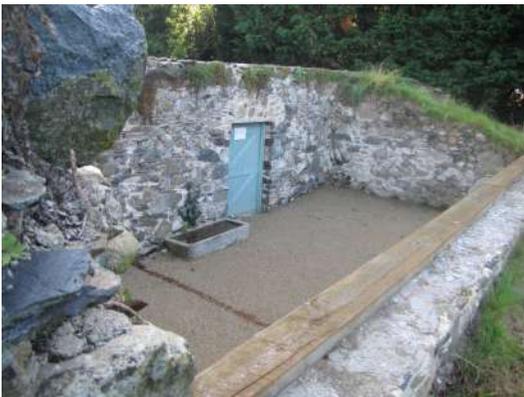
Left: The middle space, with an animal-sized door and a stone water trough which has stayed in place since it was first used... Note the line of bricks in the floor which follow the line of the foundations of the wall below it, with the family accommodation at this end of the building. There is no sign though of a chimney, nor of a mezzanine platform. Perhaps the chimney was constructed in timber and clay as a 'beehive chimney' although no trace is there.

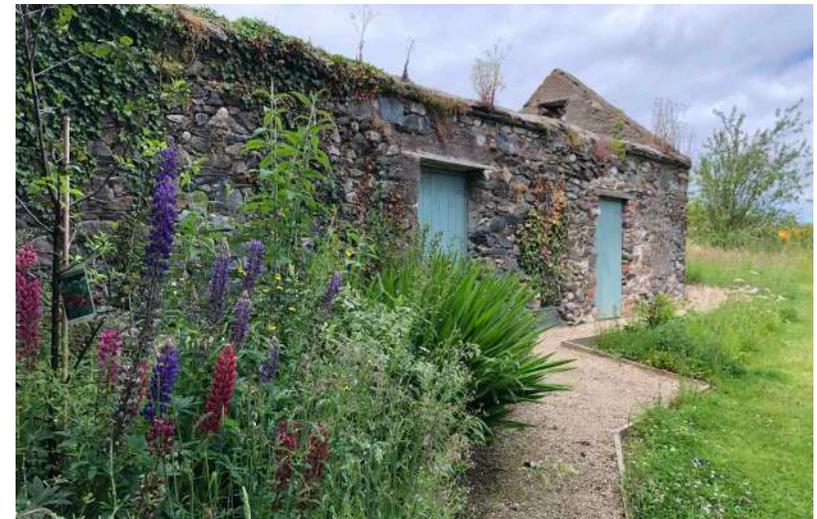
Above: A recent picture of the farmstead ruin. The pathway and garden area are recent. The roof overhang is evident here, with projecting thick slate.

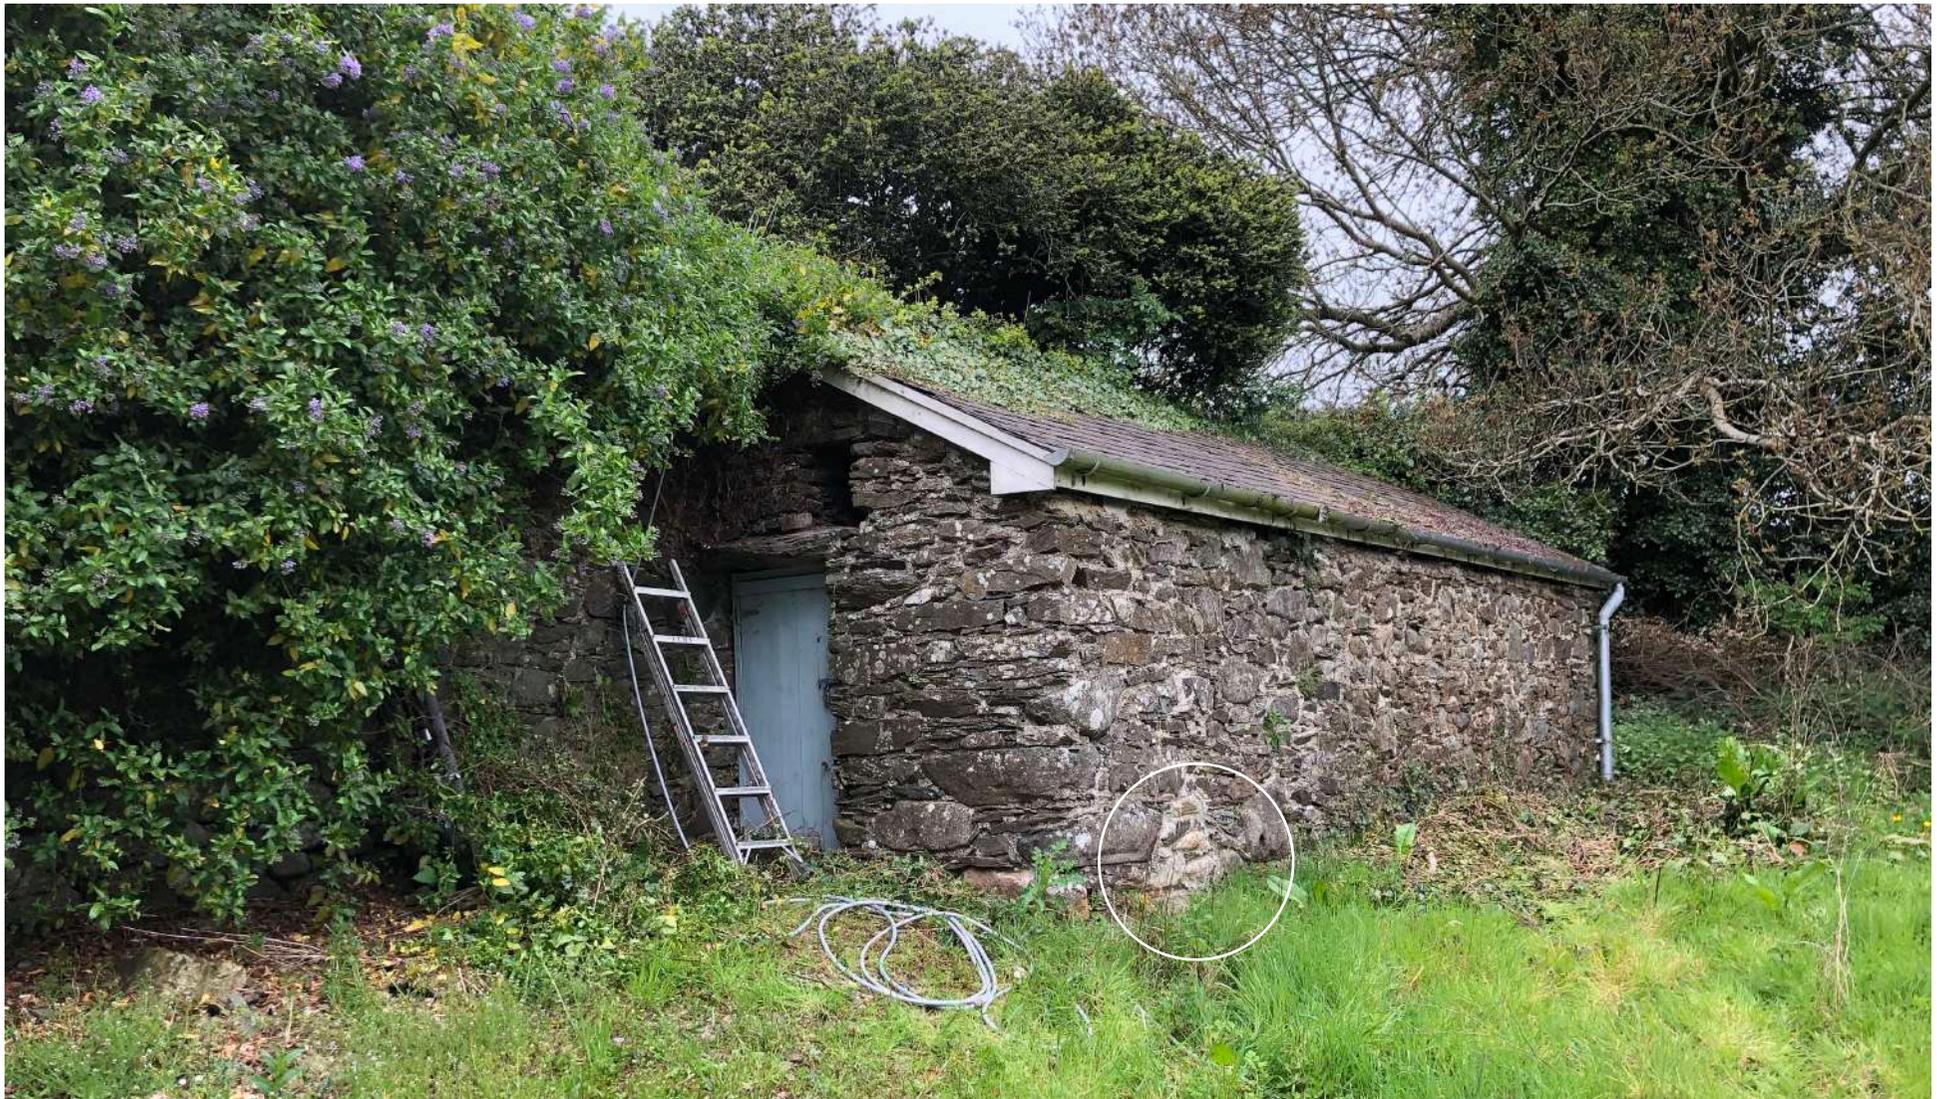
This is separate from the first farmstead... It is a complete building divided into three spaces two of them opening from the gable and a third opening on the other side into the area of the garden of the 'dower' house at the end of the farmhouse building. We believe that it was the privies for the farmstead . It was re-roofed in 2012, using additional slates from the roof repair of the stables. They are not in use though...The stonework is in good condition, and there was some evidence of an outlet through the wall, circled. Above the gable door is an opening, for ventilation.
