Ballymurrin Stories -Restoring the Quaker Farmstead  
2 The Old Stables

Ballymurrin  
Quaker  
Farmstead

## The Old Stables with Tack Room and Loft

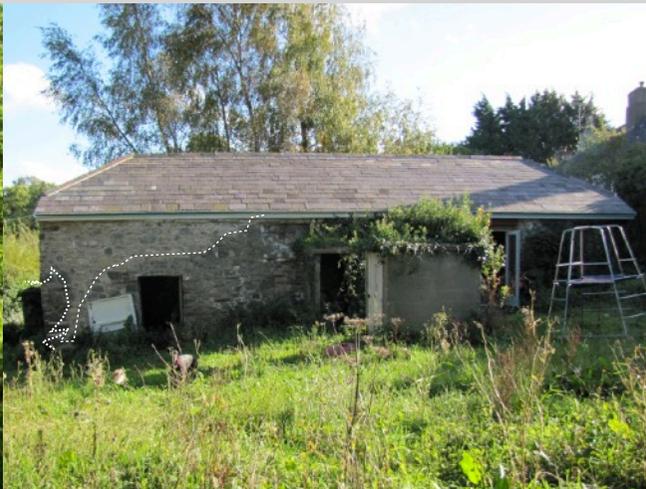
**Above:** The collapse and debris was inside the entrance for the horses. There are two substantial buttresses on either side of the opening, sloping outwards to hold the wall in place. Not the first event to befall this building!

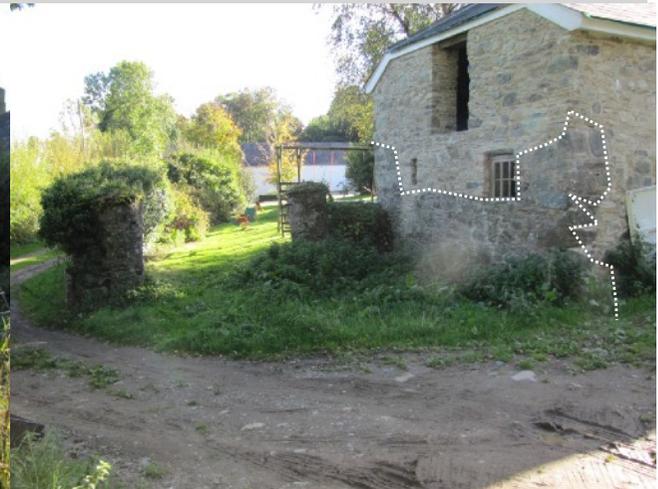
**Below:** The gable end, with loft above and small windows below. This image shows the extent of reconstruction necessitated prior to replacement to the roof.

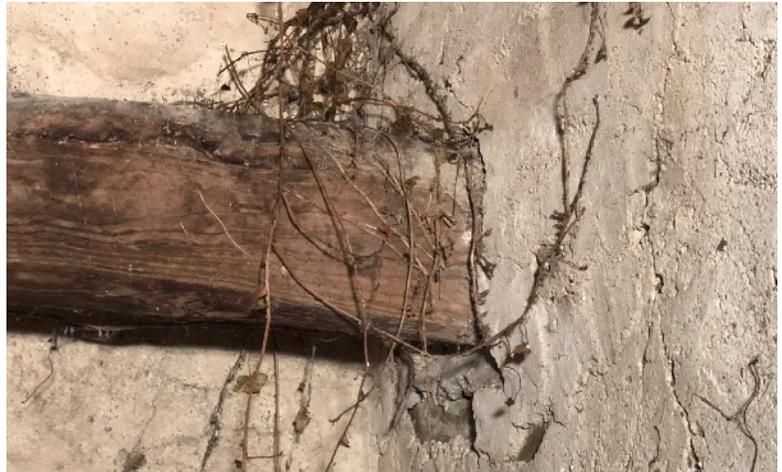
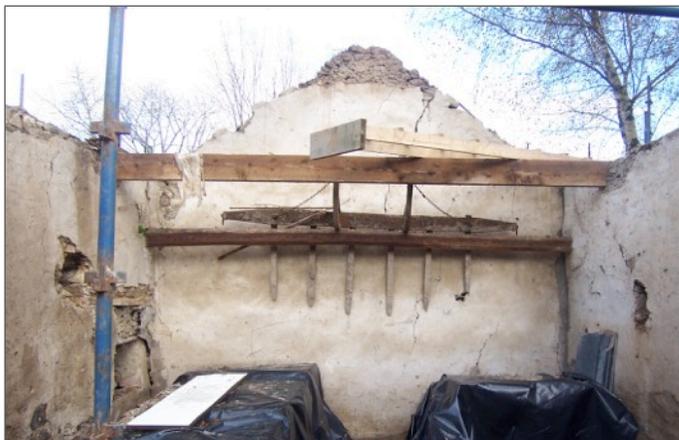
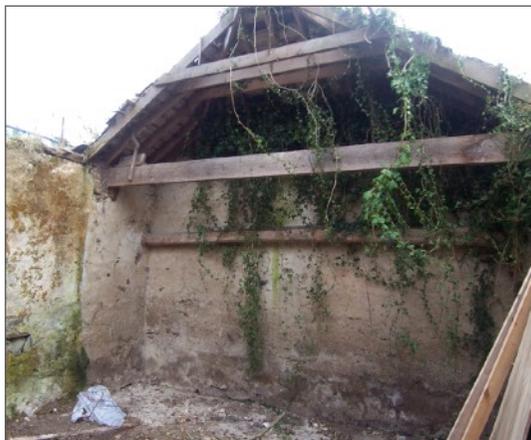
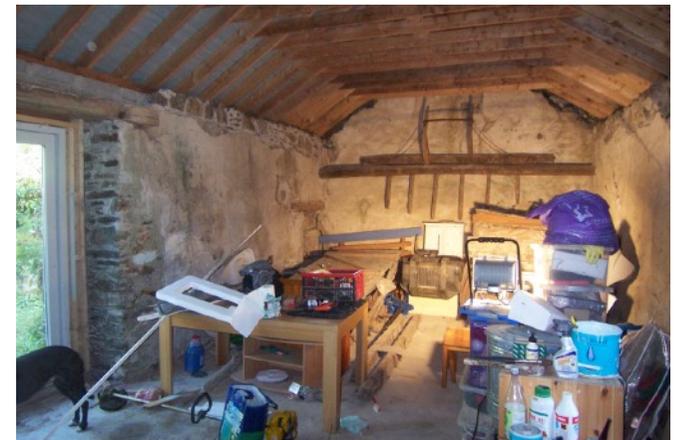
**Above:** This image shows the end of one of the two surviving beams in-situ. A third beam was unstable and was taken down. It has been retained in the building. It is close to the gable on the South side. Its purpose was to act as a tie to stabilise and hold the walls from outward pressure of the collar trusses. The beam went through the wall and was tied with an iron anchor fitting. Those fittings, remaining on the building, are shown on the previous page.

Two further beams spanning across the space, are visible in the images, **centre** and **left, below**, at both ends of the stable, are from a different time and located at a higher point on the wall. It would appear that this beam was also introduced relatively recently to limit the pushing out of the wall,

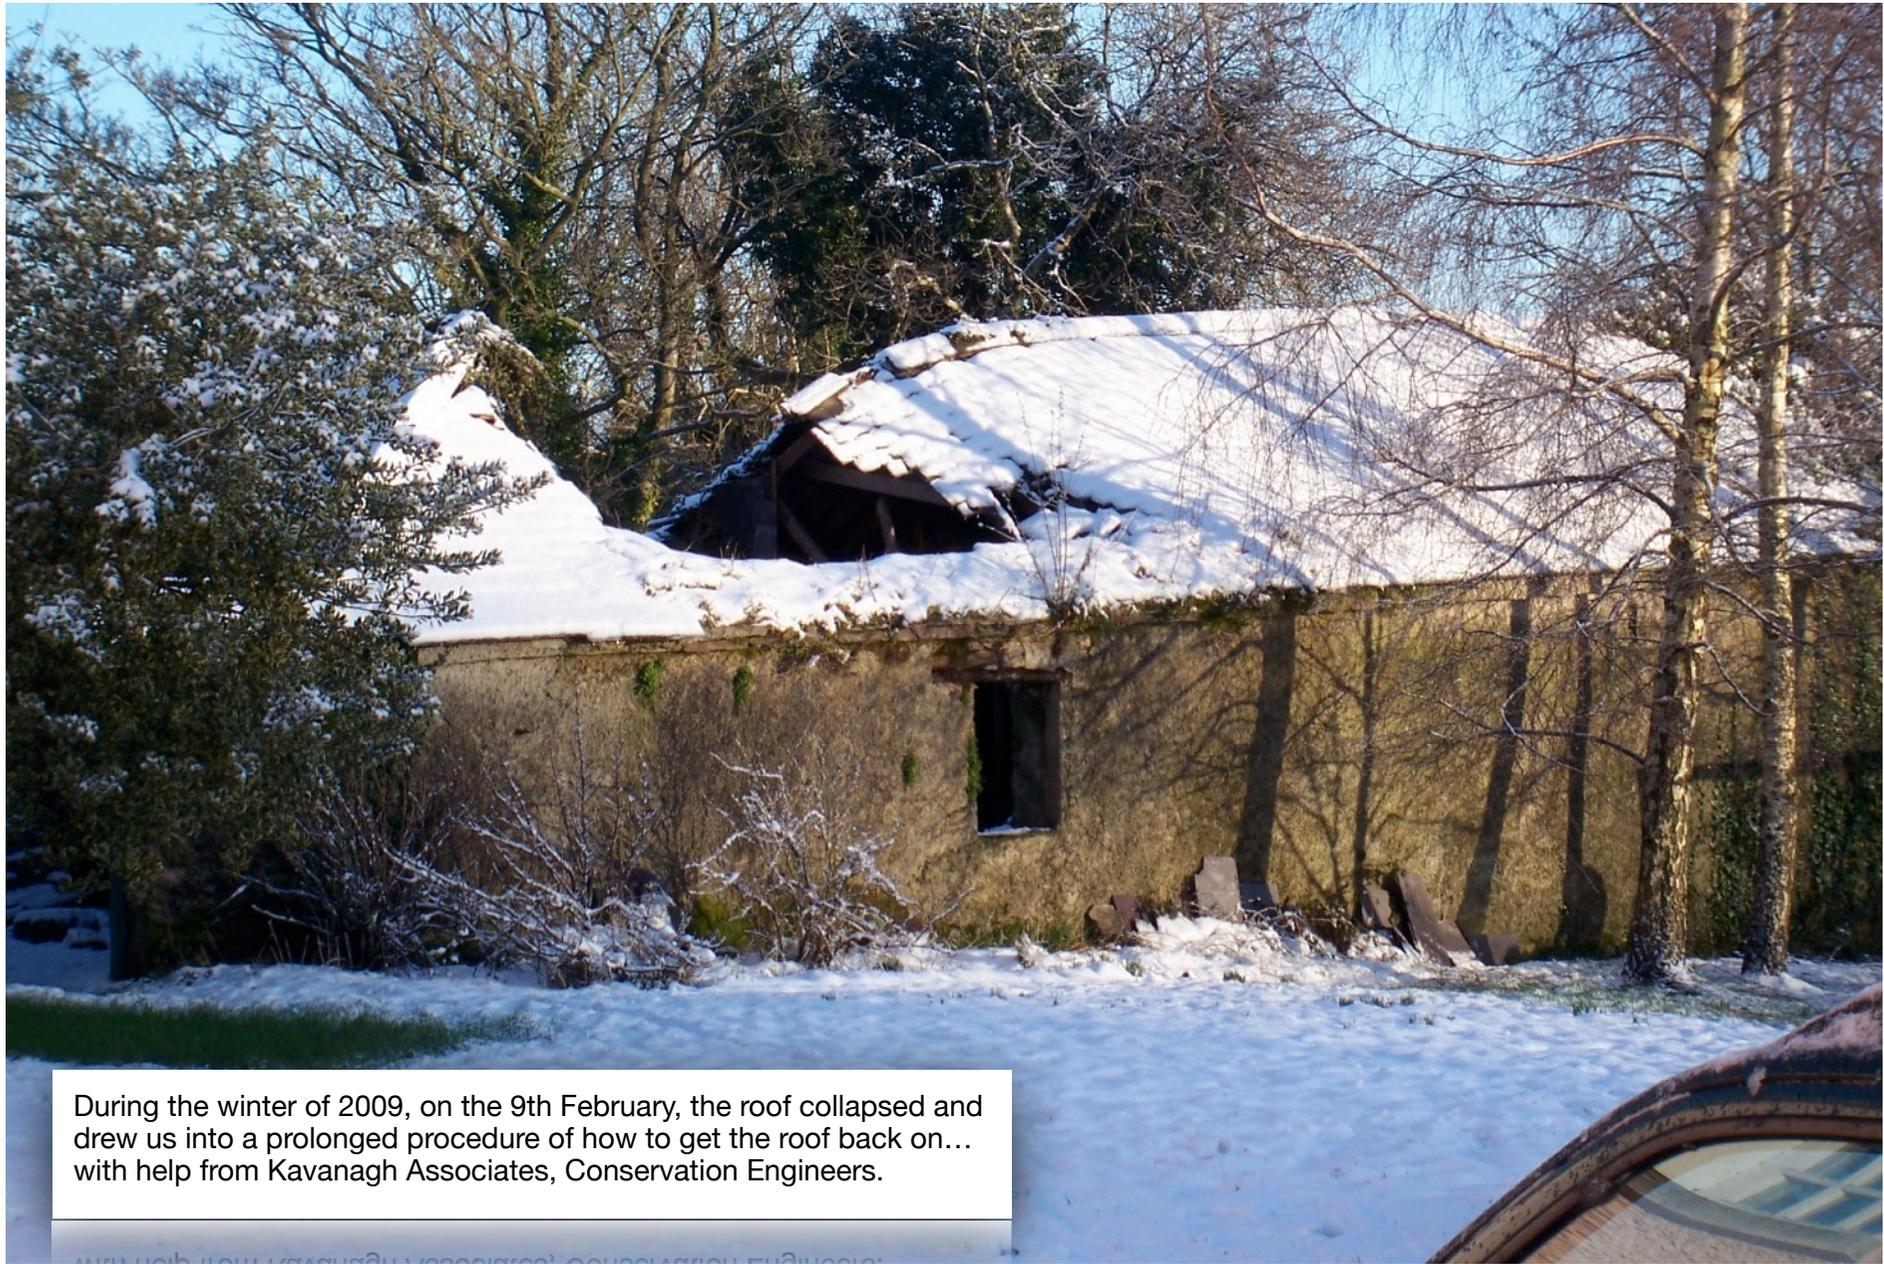
During the winter of 2009, on the 9th February, the roof collapsed and drew us into a prolonged procedure of how to get the roof back on... with help from Kavanagh Associates, Conservation Engineers.
